Analysis on the Weather Circumstance Involved in the UH-60M Helicopter Incident on 2 January 2020

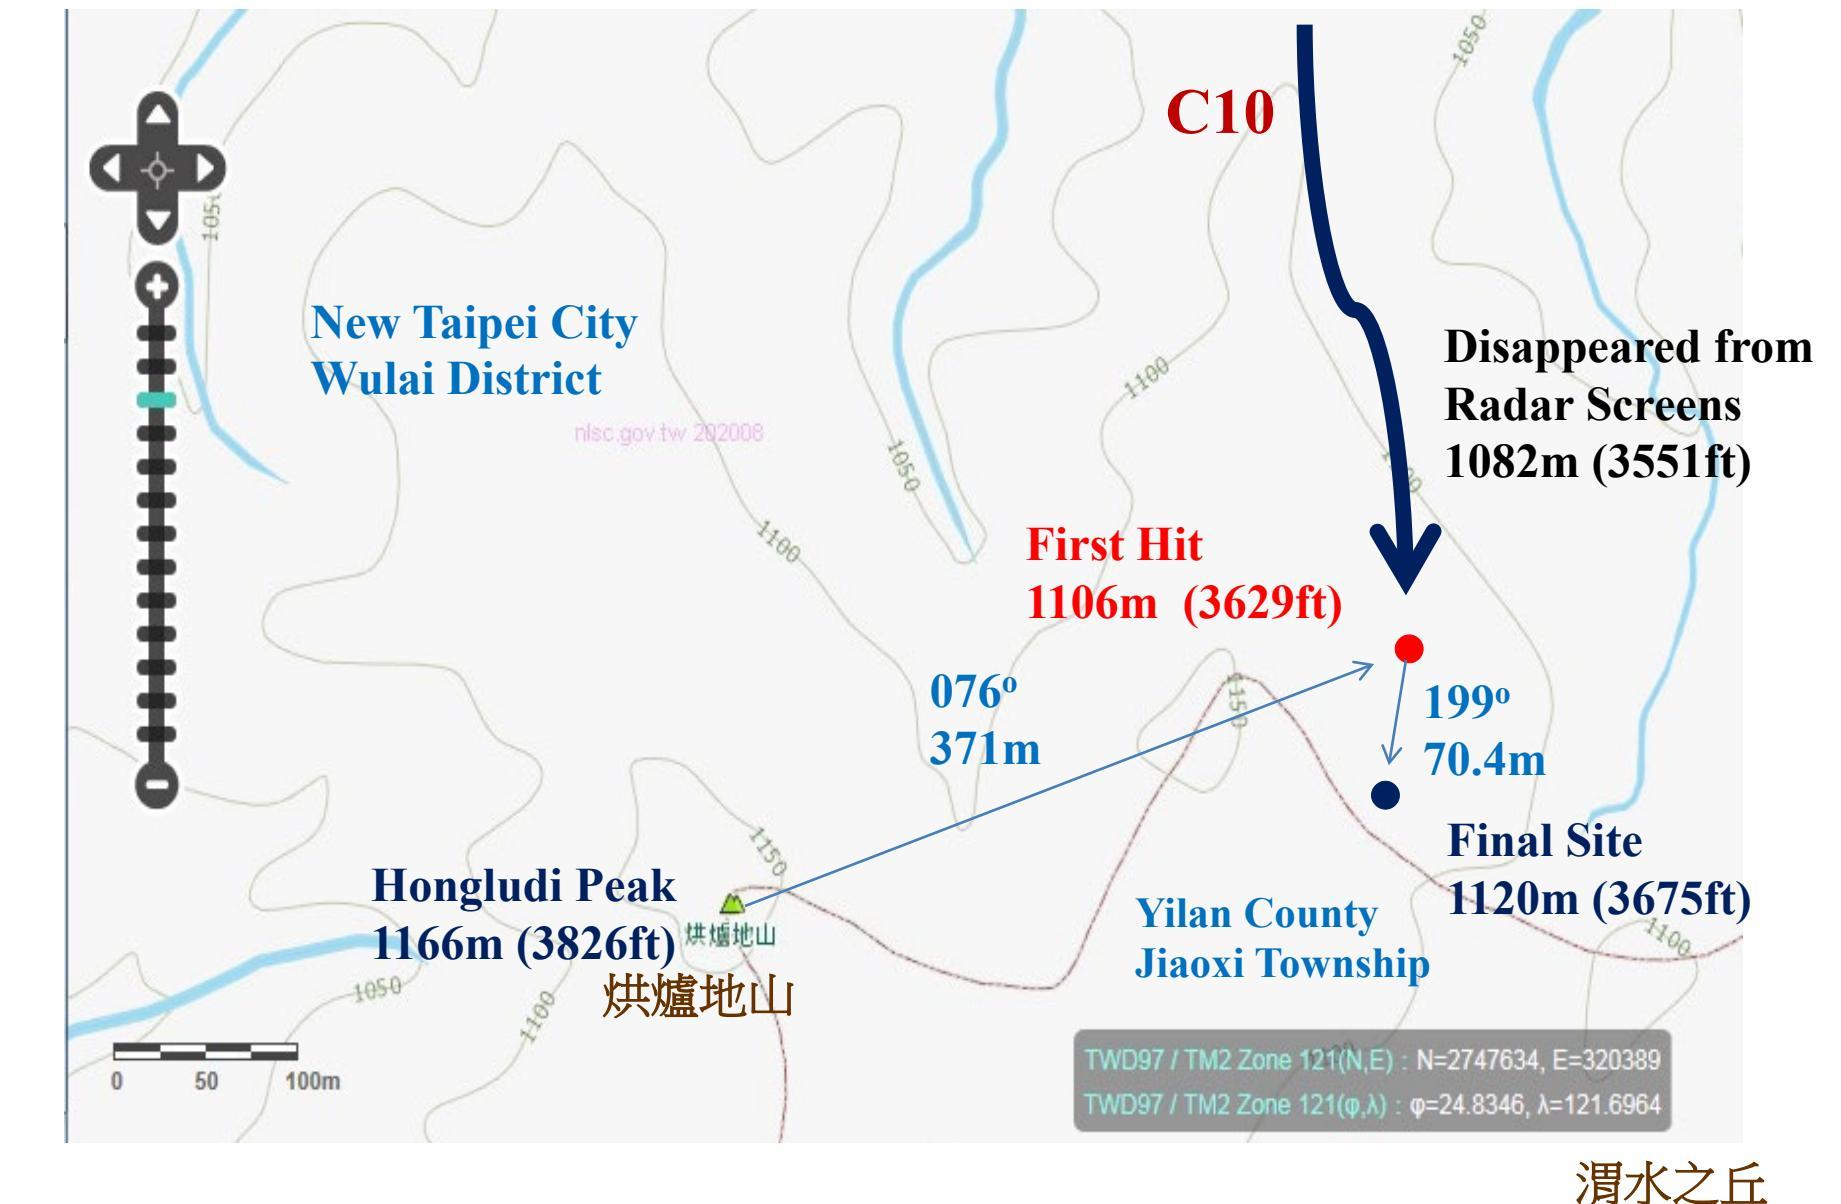
Fig. 14. The reconstruction map of crash site for ROCAF UH-60M helicopter on 2 January 2020. The peak of Hongludi ridge in altitude of 1166m (3826 ft) ASL is the landmark, and the bold black arrow is the flight track. (Made by T. H. Hor referring from MOI NLSC map and MND Preliminary Investigation Report of the UH-60M Incident on 15 February 2020)

The flight altitude of the UH-60M black hawk (No.933) was too low, and the main rotor blades hit the branches of trees on the hill before its crash at 0807:01.2TST on 02 Jan. 2020.

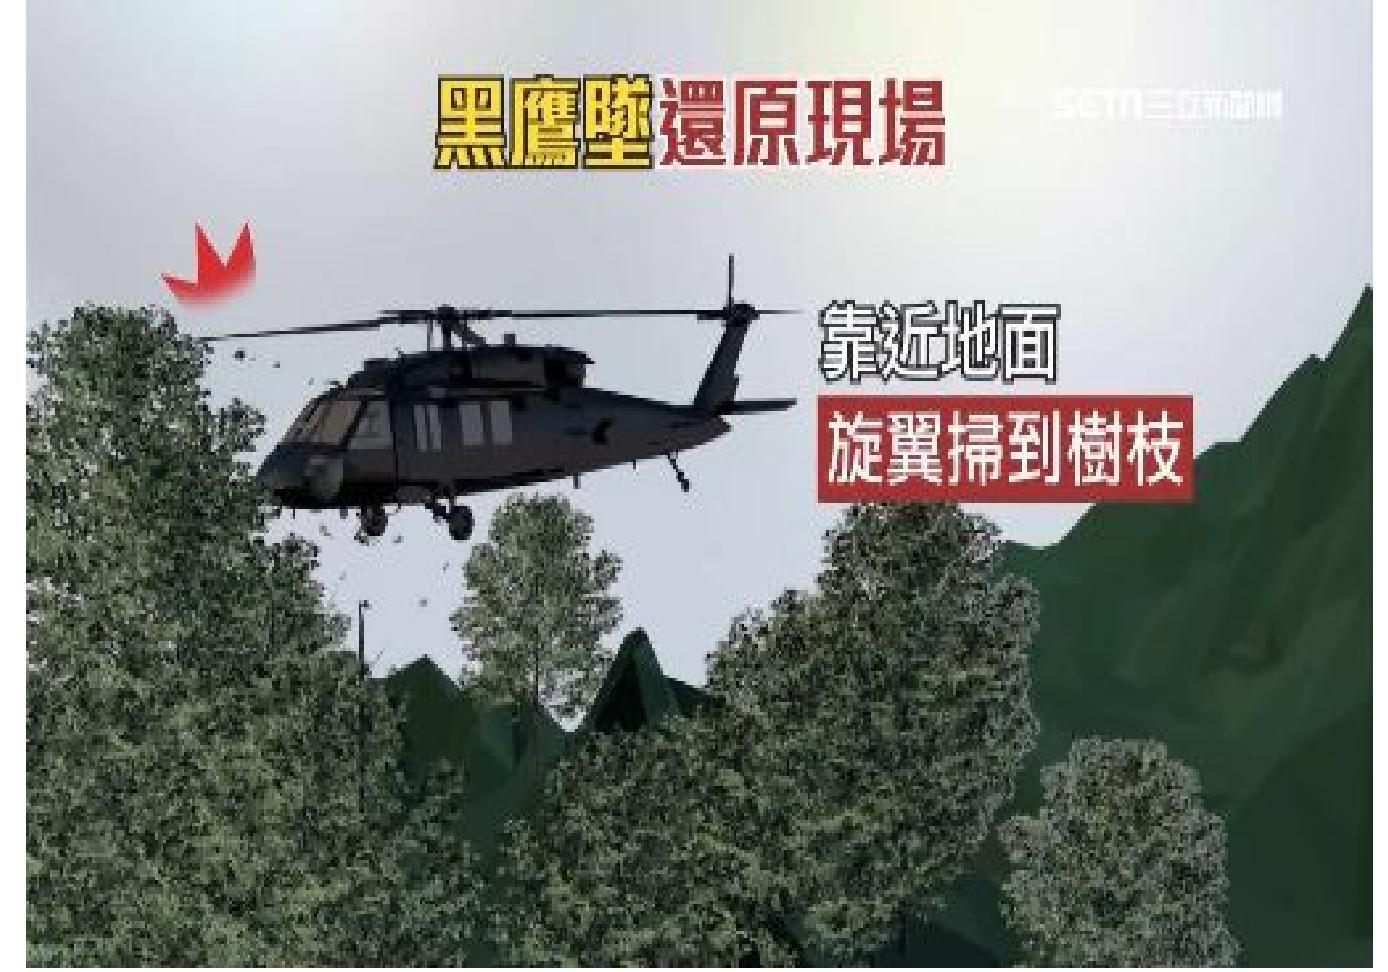
Disappeared from Radar Screens 1082m (3551ft)

First Hit 1106m (3629ft)

Final Site 1120m (3675ft)

Hongludi Peak 1166m (3826ft)

黑鷹失速驟降後旋翼撞擊樹枝。 黑鷹失事/報告出爐!2因素害墜地翻滾,機腹滑行70公尺。 三立新聞台記者葉為襄,2020/02/15

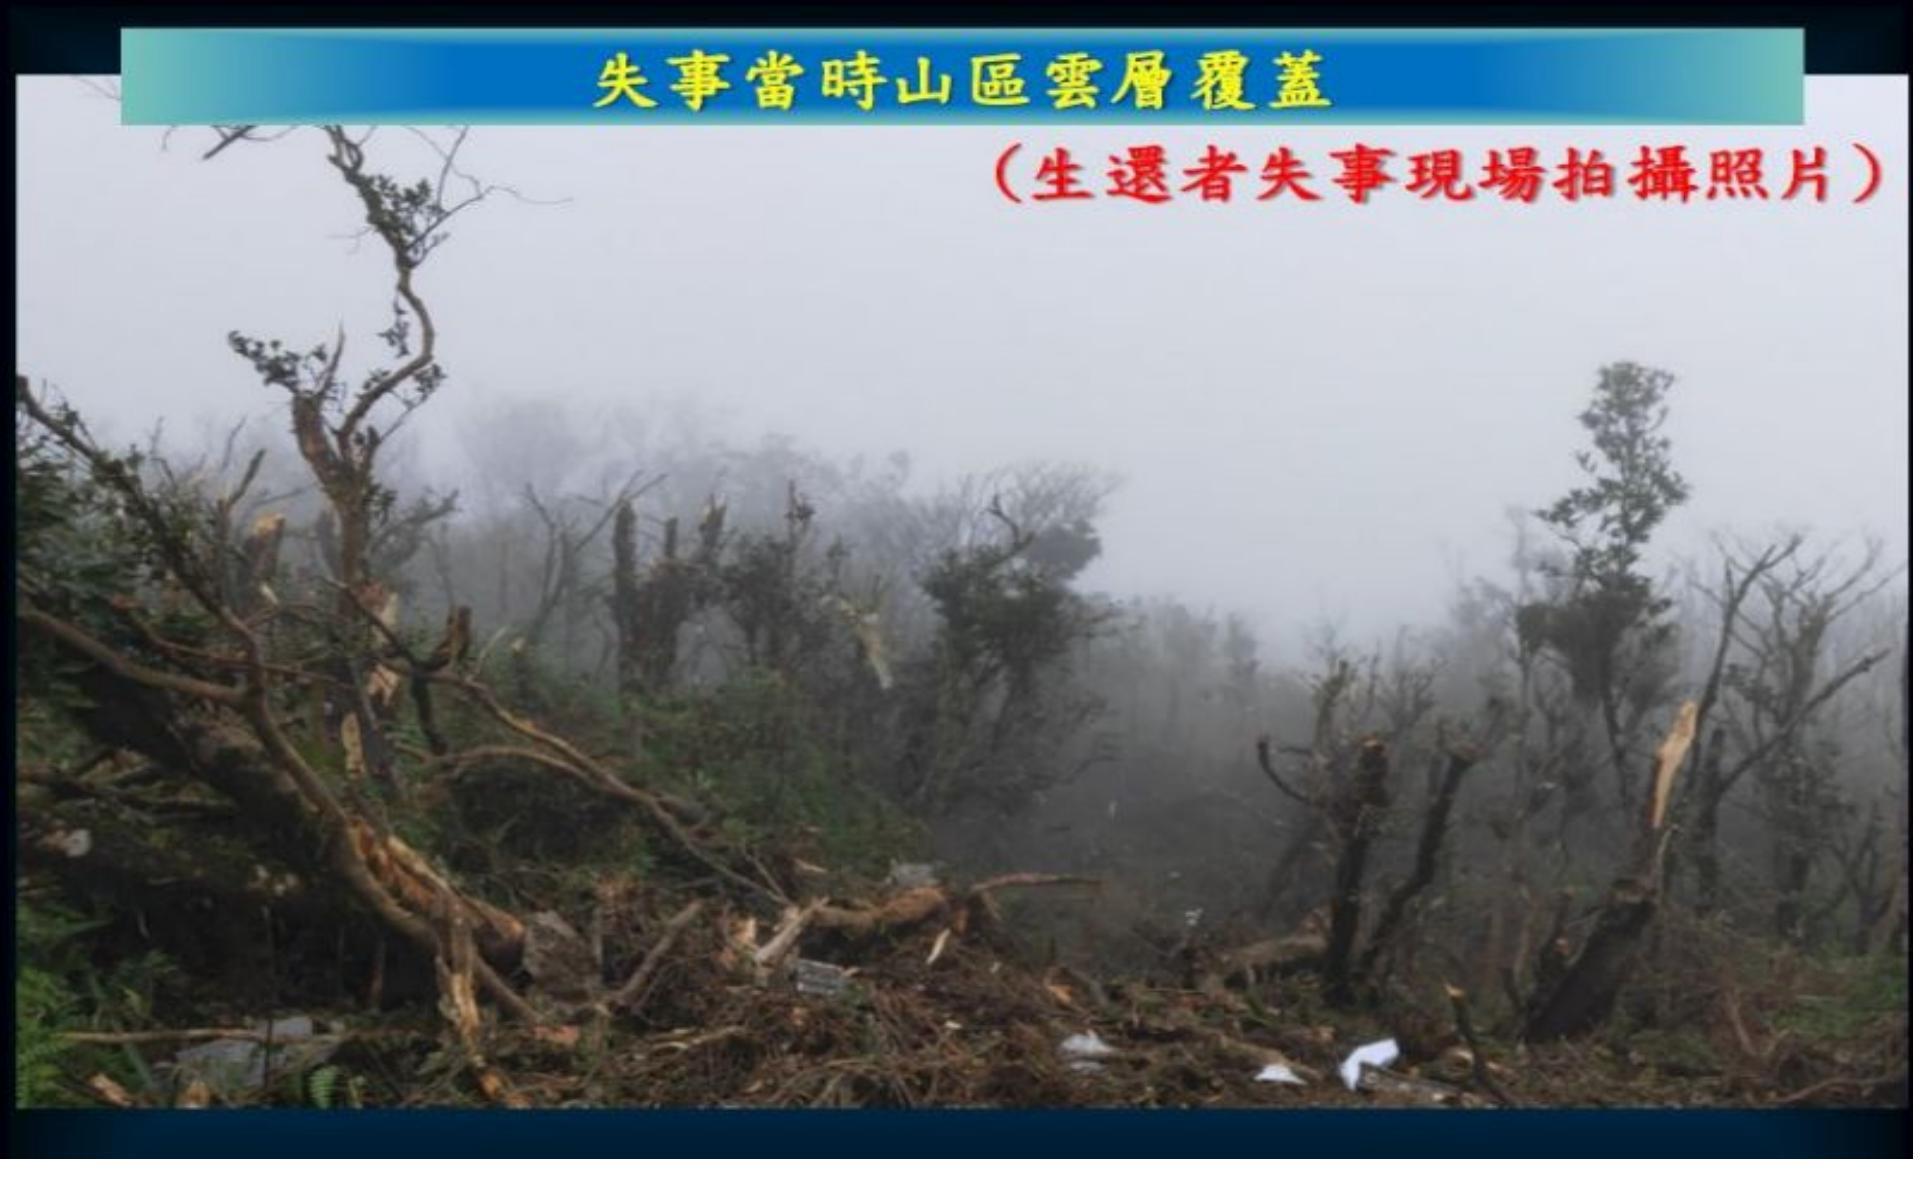
Fig. 10 The weather situation at that time in the UH-60M helicopter crash site offered by MND on 15 February 2020. 黑鷹失事5人遭懲處 空軍司令、副司令記過 2020/02/15 三立新聞政治中心(圖/國防部提供)

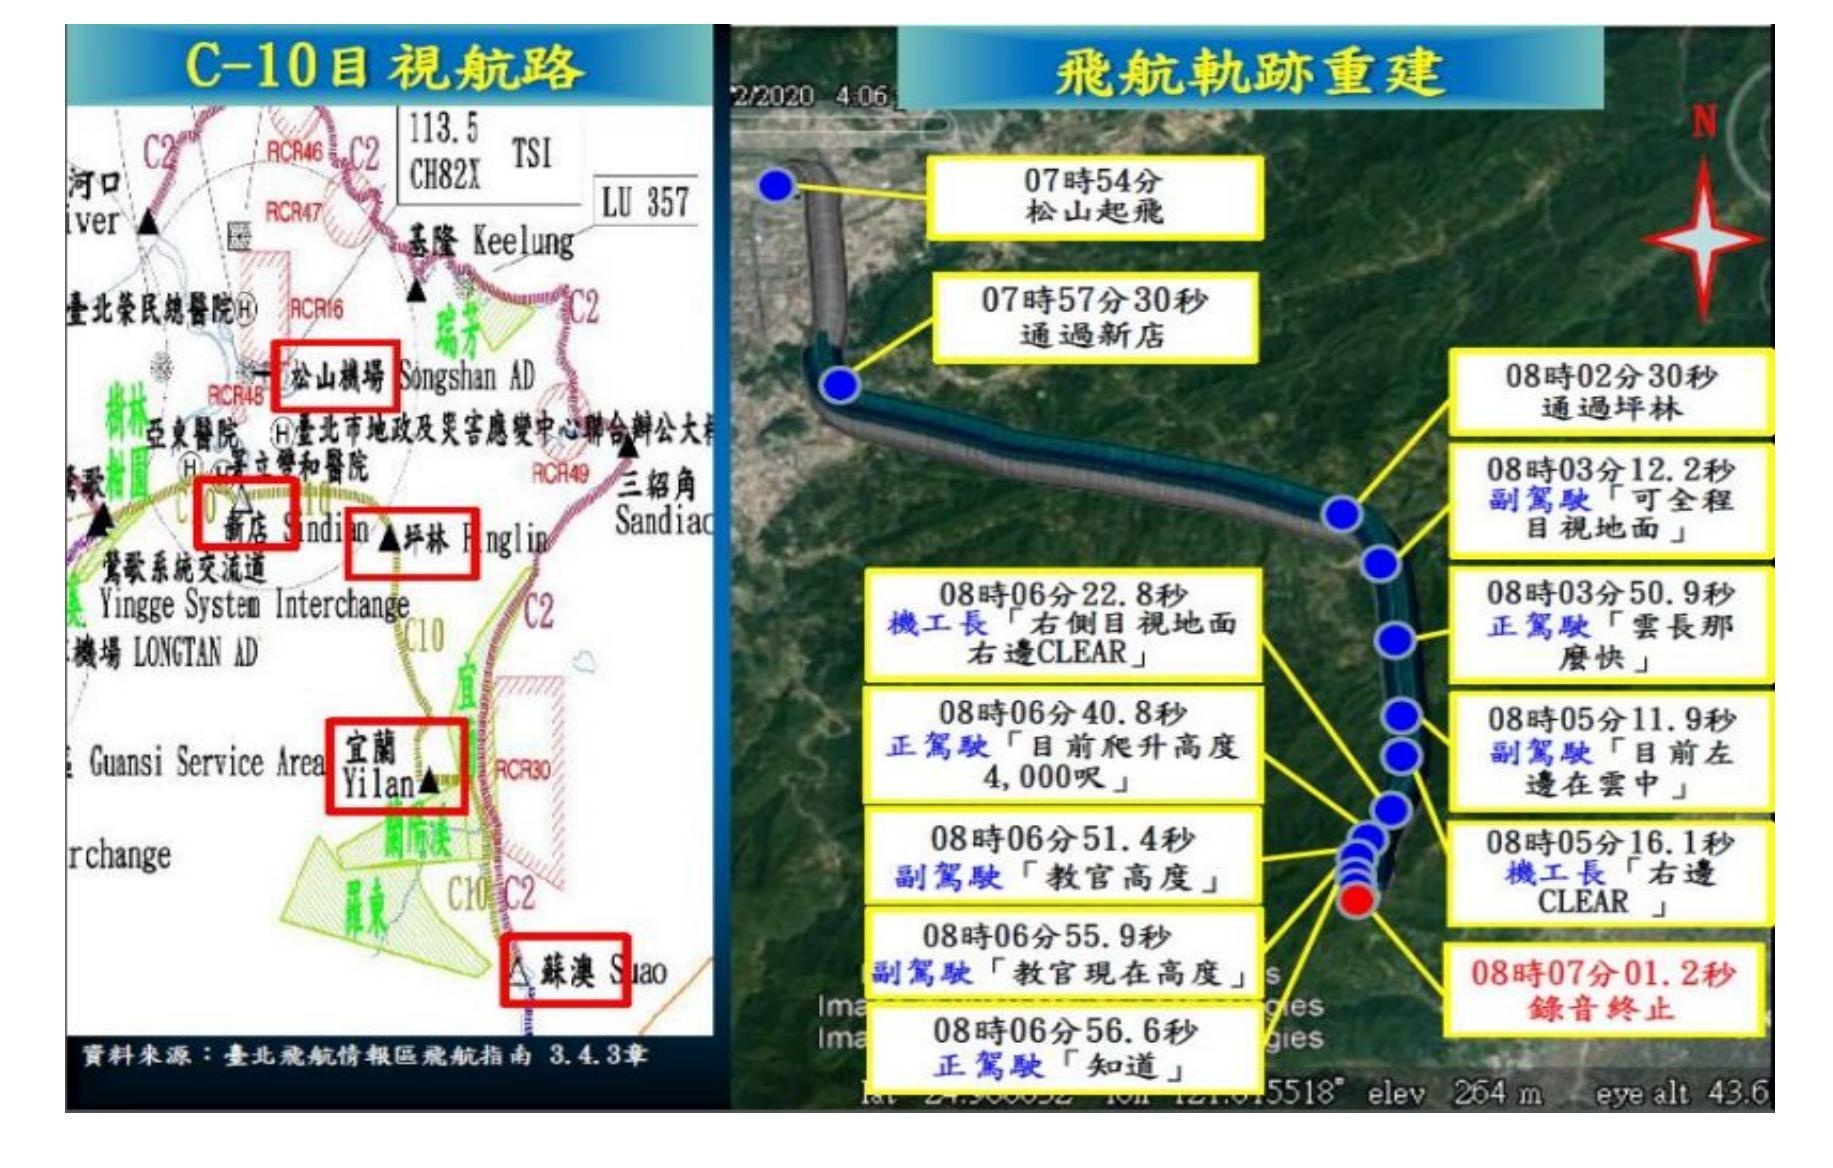
Fig. 13. (a) The C-10 visual flight route map. (b) The reconstruction of flight trajectory for ROCAF UH-60M helicopter on 2 January 2020, including time(TST), and dialogue remarks in the cockpit. (Referred from the ROC MND Preliminary Investigation Report of the UH-60M Incident on 15 February 2020) 資料來源:黑鷹失事5人遭懲處 空軍司令、副司令記過 2020/02/15 三立新聞政治中心

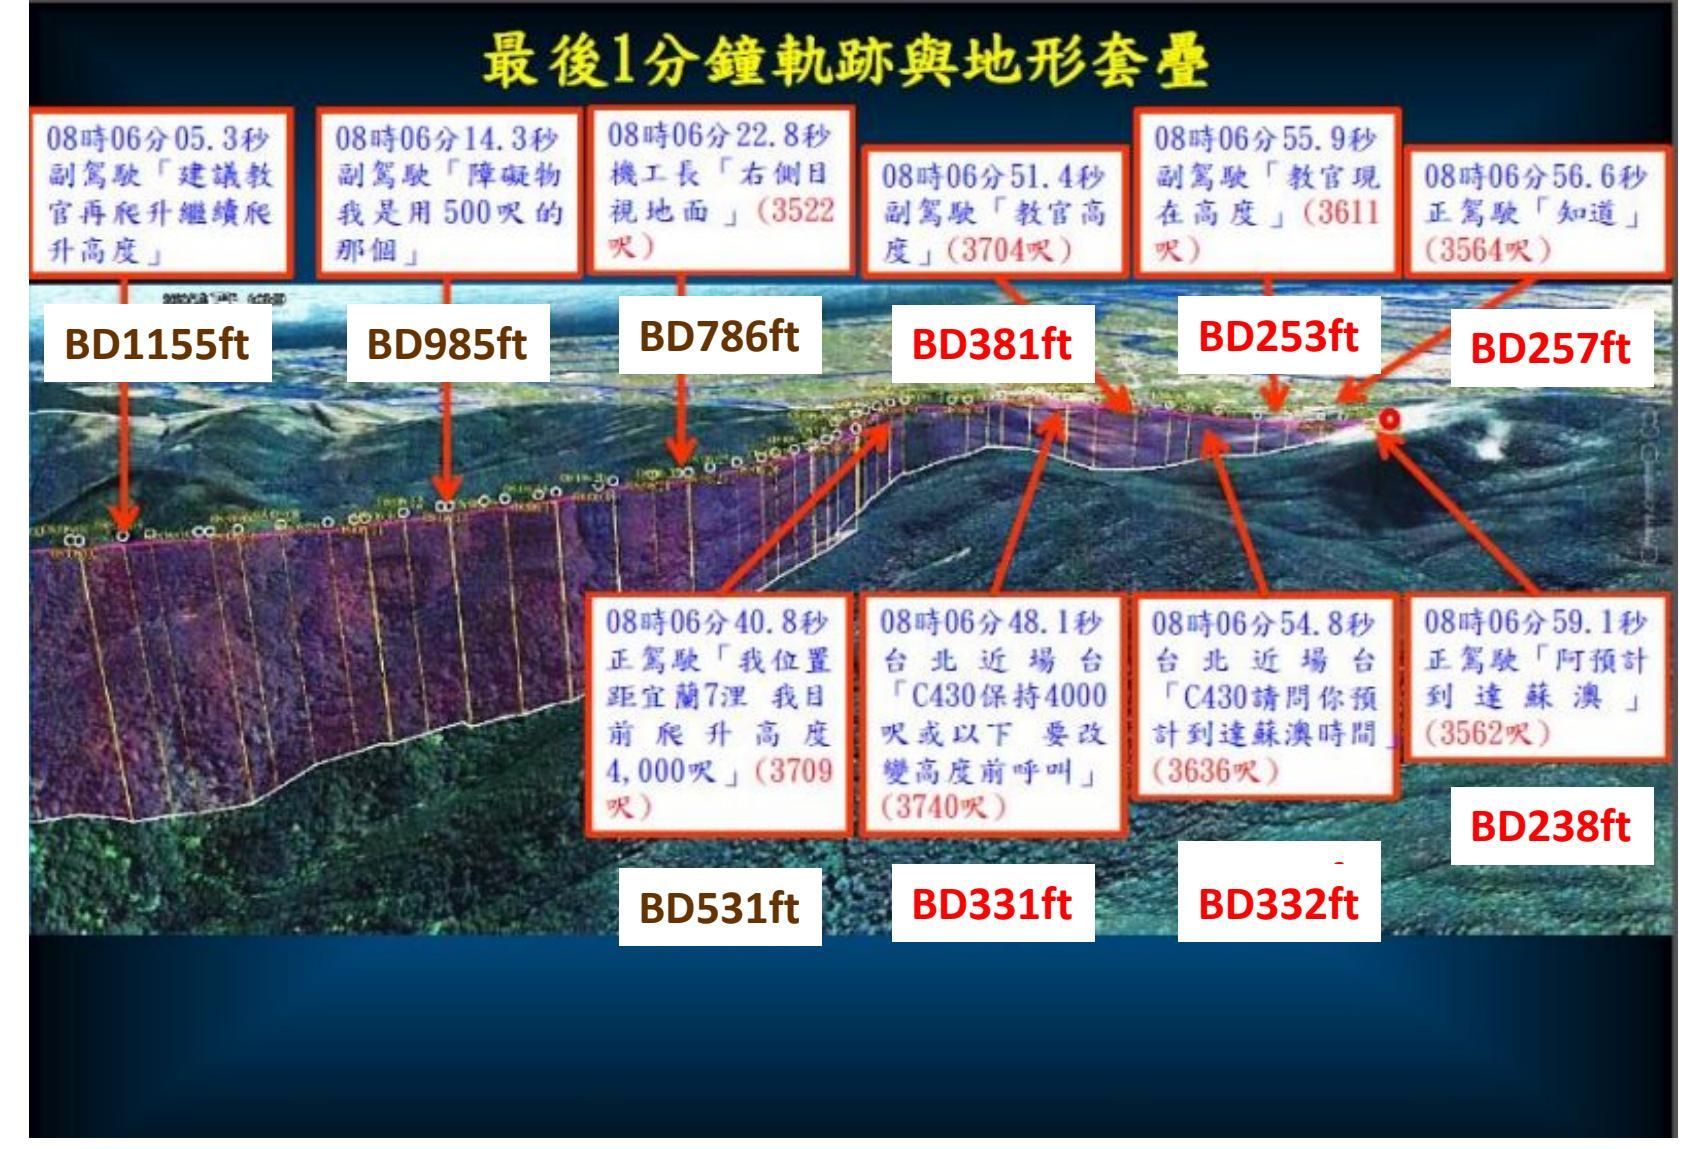
Fig. 15. The overlay of flight trajectory and topography during the last minute before ROCAF UH-60M helicopter accident on 2 January 2020, including time(TST), plane altitude(ft), and dialogue remarks in the cockpit. (Referred from the ROC MND Preliminary Investigation Report of the UH-60M Incident on 15 February 2020) 黑鷹失事5人遭懲處 空軍司令、副司令記過 2020/02/15 三立新聞政治中心

TIME (TST)	0102 0803 50.9	0102 0806 05.3	0102 0806 14.3	0102 0806 22.8	0102 0806 40.8	0102 0806 48.1	0102 0806 51.4	0102 0806 54.8	0102 0806 55.9	0102 0806 56.6	0102 0806 59.1	0102 0807 00.2	0102 0807 01.2
Plane alt. (ft)	2631	3357	3384	3516	3709	3740	3708	3646	3615	3604	3560	3552	3551
Barrier dis. (ft)	1592	1155 (1)	985	786	531	331	381 (2)	332	253 (3)	257	238	170	87
Plane speed (knot)	105	77	77.3	56.1	67.7	75	85.2	99.6	103.3	106	117	119.4	118.8

Table 2. Selected flight data list for occurrence UH-60M helicopter on 2 January 2020, including plane altitude (ft), barrier distance (ft), and plane speed (knot, 1 knot =1nautical mile/hour). "TST" represents the Taiwan Standard Time (UTC+8). The electronic tac map in the cockpit will turn to red while the barrier distance is under 500 ft. (Referred from the ROC MND Preliminary Investigation Report of the UH-60M Incident, 2020)

(1) 080605.3 副駕駛:「建議教官再爬升,繼續爬升高度」。
(2) 080651.4 副駕駛:「教官高度」。
(3) 080655.9 副駕駛:「教官現在高度」。
資料來源:黑鷹失事前通聯紀錄曝光。關鍵評論, 2020/02/15。

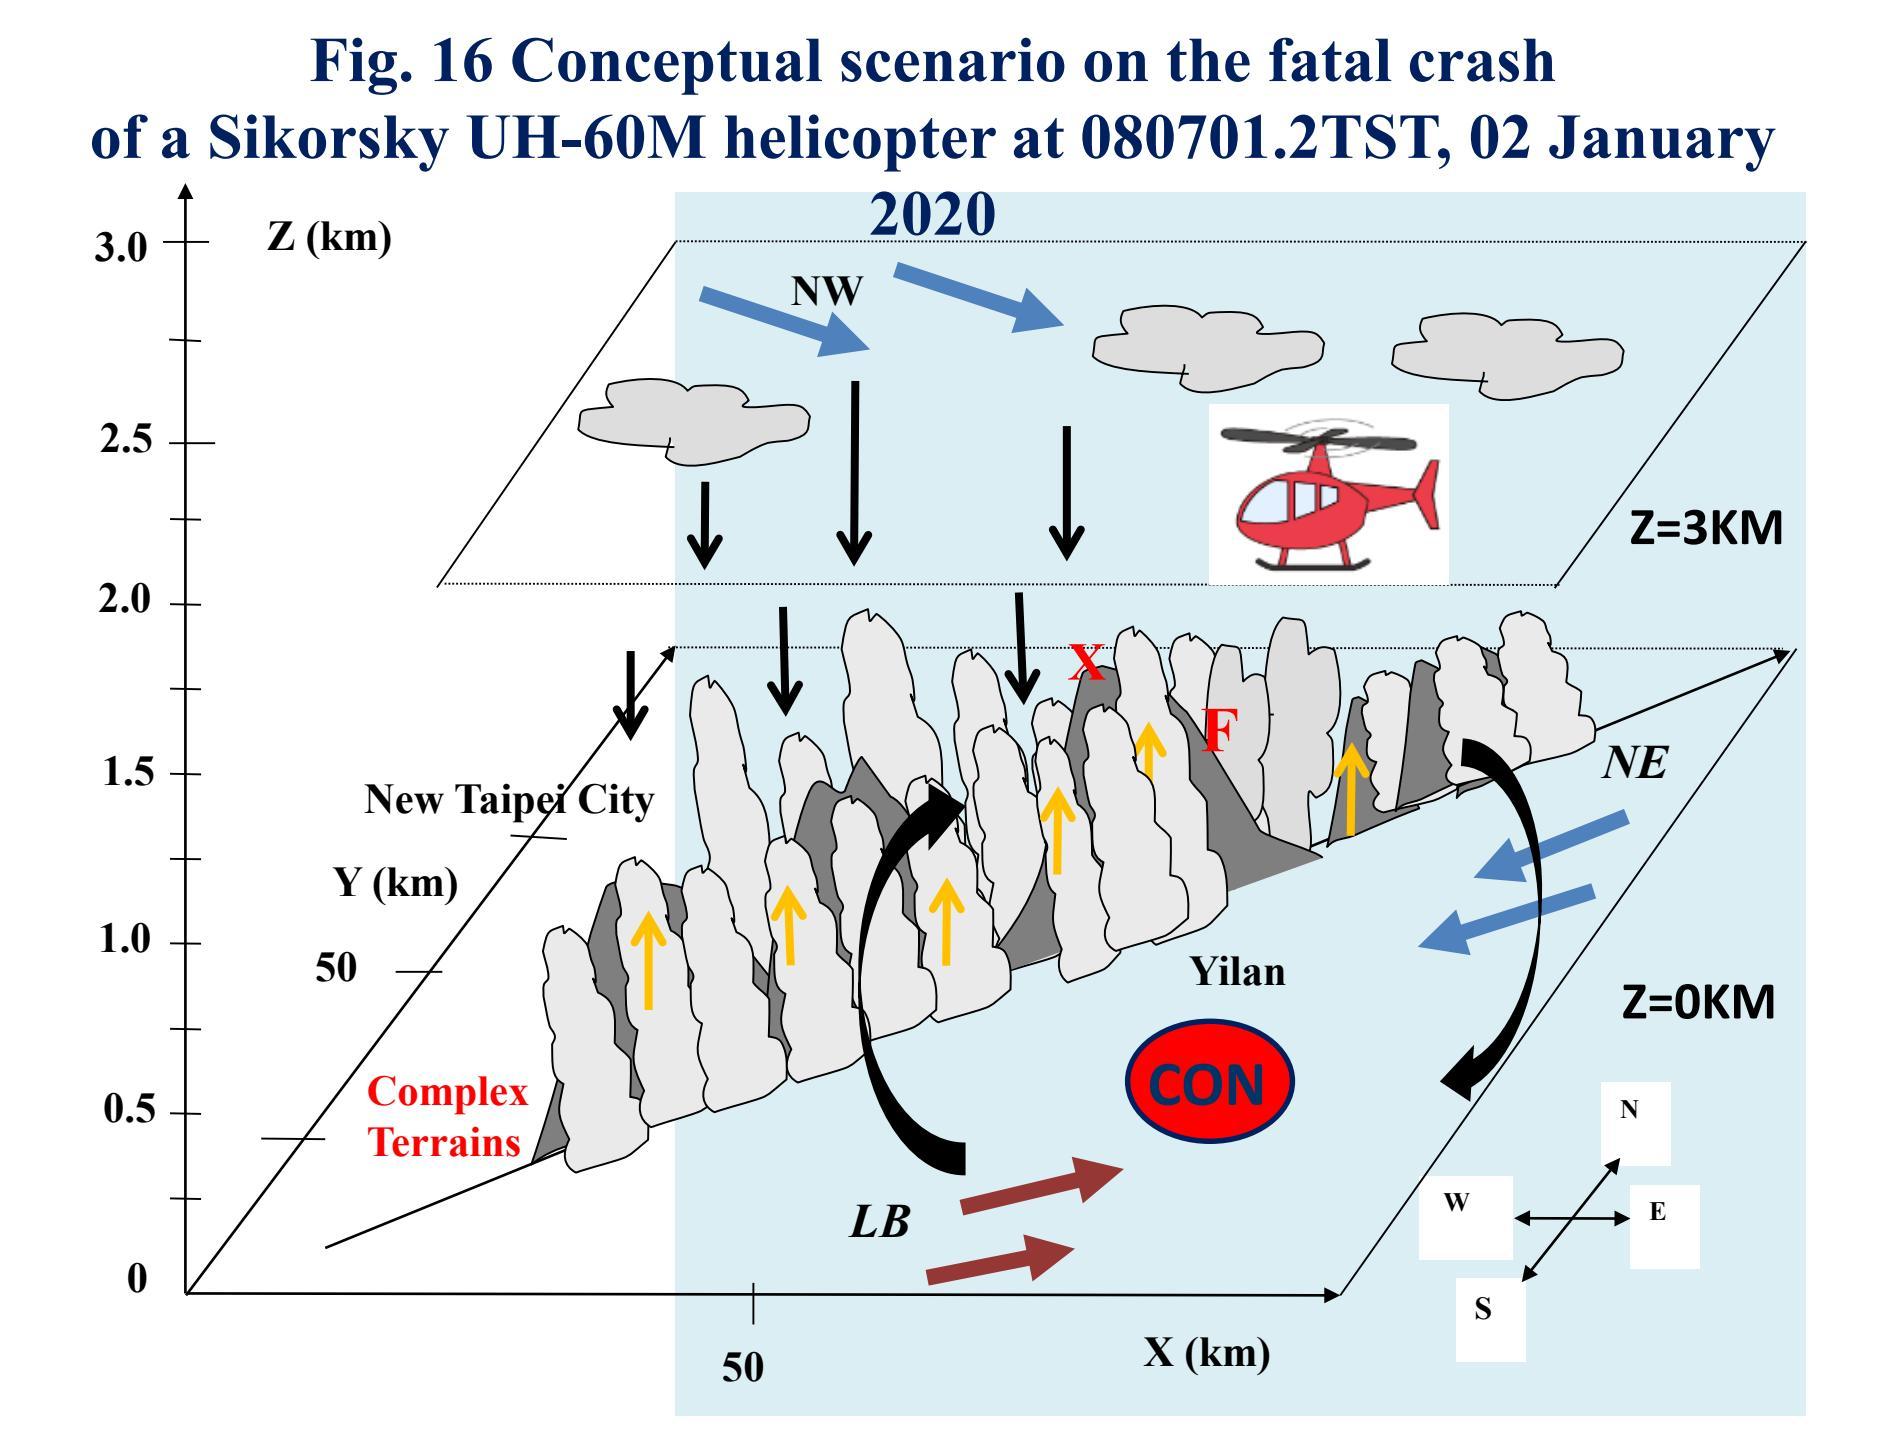
3-D Conceptual Model on Weather Pattern in C-10 Flight Route on 02 Jan. 2020 under the Presence of Taiwan Orography

Fig. 16 The schematic conceptual model for the weather pattern in C-10 flight route on 02 January 2020 under the presence of Taiwan orography. Under the large scale weather conditions of weak NE monsoon and abundant moisture supply over the north Taiwan, an obviously local convergence zone was formed over the Yilan Plain due to the interaction of prevailing NE wind and land breeze as well as the blocking of complex terrains. In the figure, the "NE" and "LB" stand for the northeast monsoon and land breeze, respectively. The black and yellow arrows are for downflows and upflows, respectively, and "X" is the peak of Hongludi ridge in altitude of 1166 m (3826 ft). Also, "F" shows the final site of ROCAF UH-60M helicopter incident in altitude of 1120m (3675ft). The more detailed description was shown in Hor, et.al., 2020.
