Analysis on the Weather Circumstance Involved in the UH-60M Helicopter Incident on 2 January 2020

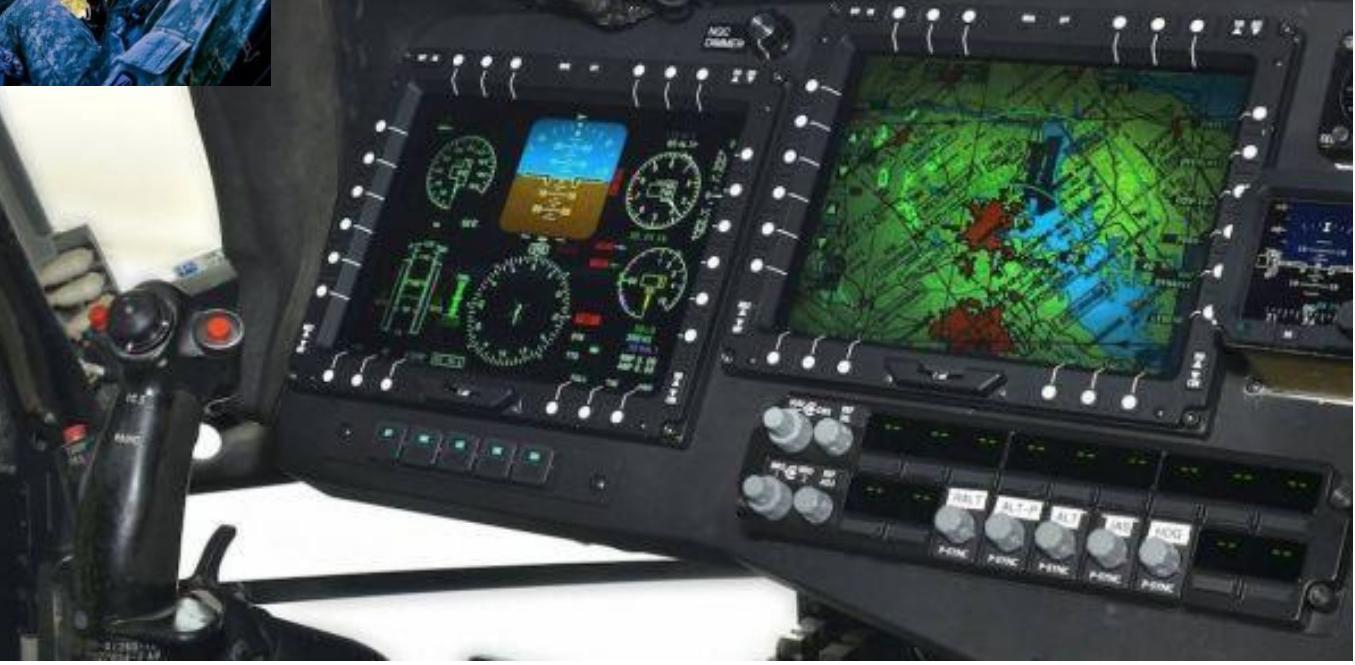
The electronic tac map in the cockpit will turn to red while the barrier distance is under 500 ft. 参考消息 http://www.news.cn/cankao/

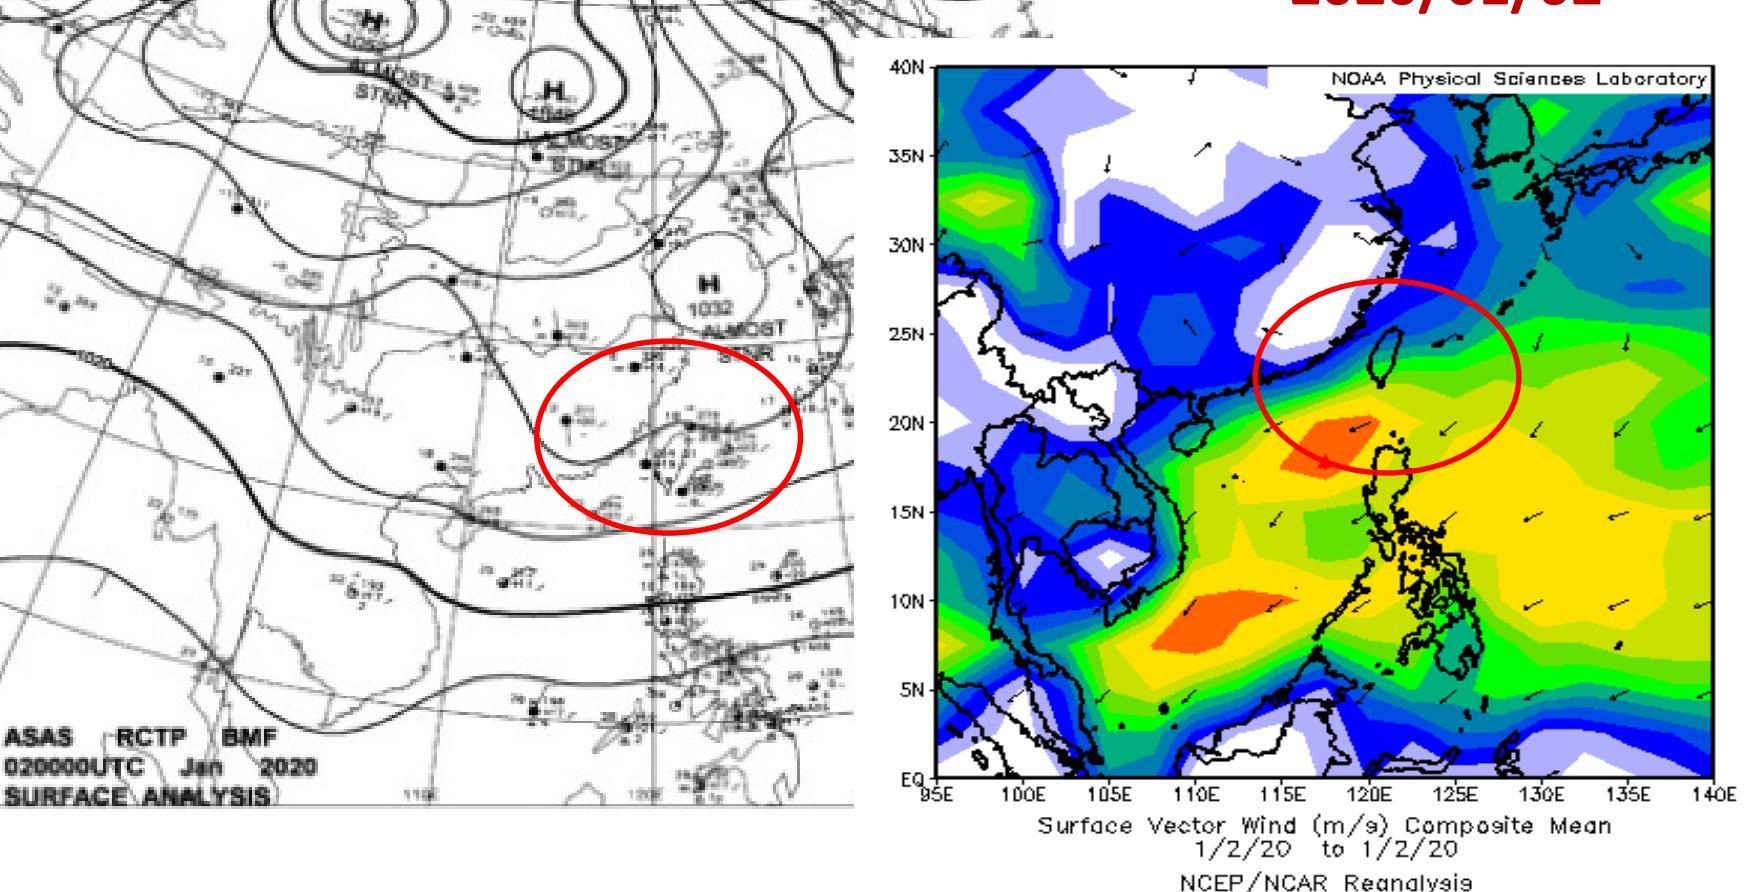
- The surface weather map at 0000UTC on 2 January 2020 mentioned that the southeastward movement of split high in slight pressure gradient was located at the East China Sea and it brought weak NE monsoon over the north Taiwan area.
- The composite mean surface vector wind distribution in synoptic scale on 2 January 2020 over the Northwest Pacific Ocean showed the strong NE monsoon was prevailing over the open ocean with weak NE wind over the Taiwan area.

Fig. 1 (a) The surface weather map at 0800TST (UTC+8) on 2 January 2020. (Referred from the Central Weather Bureau) (b) Composite mean surface vector winds (m/s) between EQ-40°N and 95°E-140°E on 02 January 2020. (Resulted from NOAA/ESRL)

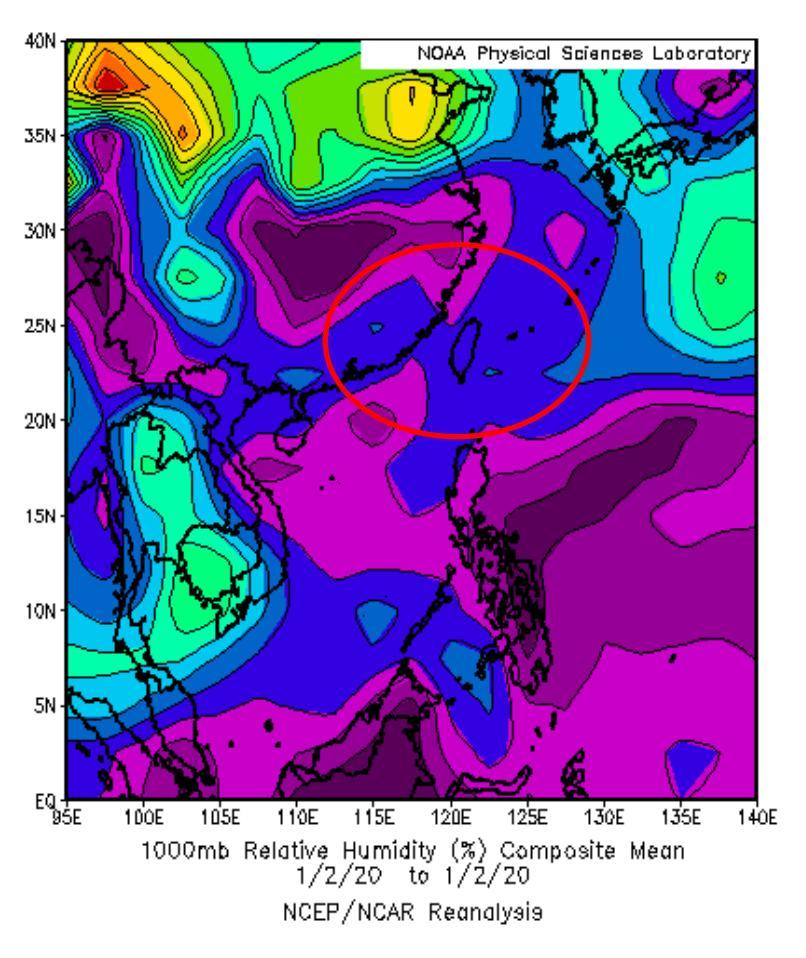
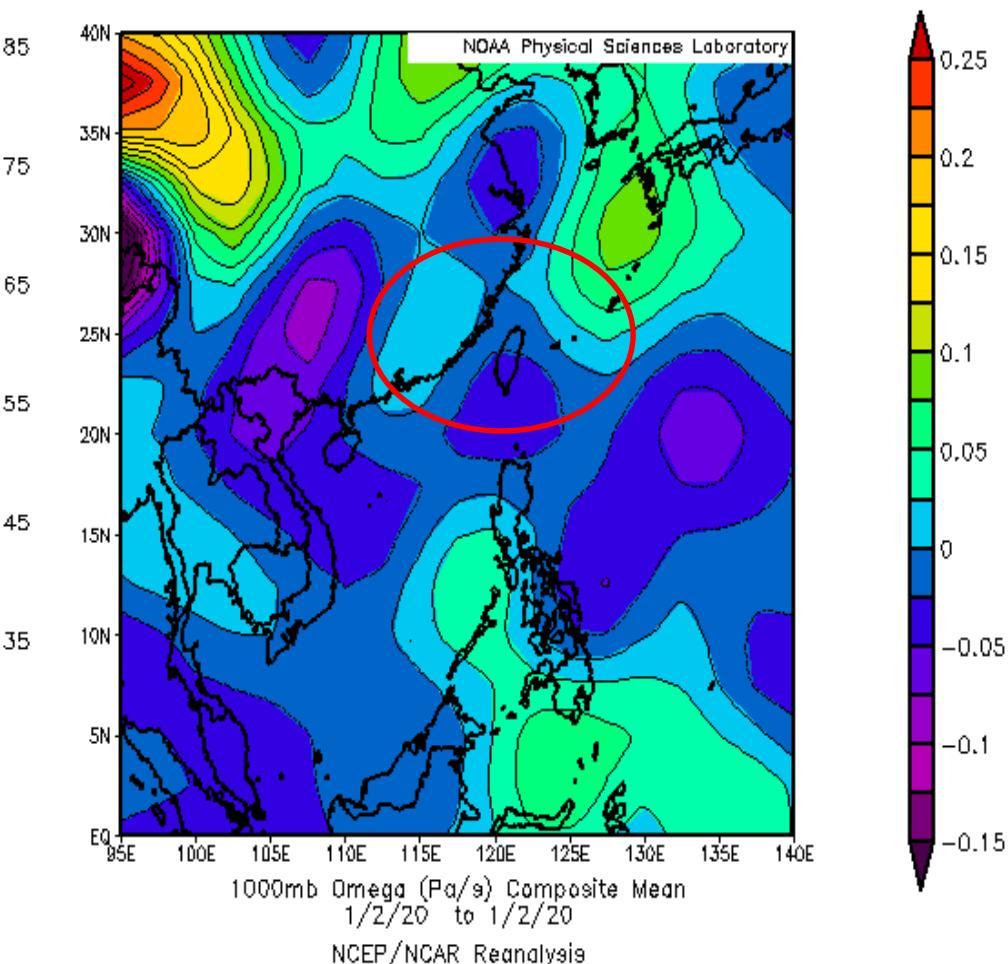
- Also, the composite mean relative humidity in 1000hPa level on 2 January 2020, supported the finding, an abundant moisture distribution (RH>80%) over the Taiwan area.
- Again, the composite mean omega distribution in 1000hPa level illuminated the slight vertical motion in the vicinity of Taiwan, a feasible condition for local circulation and cloud over the Taiwan area.
- The local weather pattern in the early morning over the Yi-lan Plain was affected by the combination of prevailing weak NE wind and land breeze, and resulted in cloud initiatives.

Fig. 2 Composite mean 1000 hPa-level relative humidity (%), and omega (Pa/s) between EQ-40°N and 95°E-140°E on 02 January 2020. (Resulted from NOAA/ESRL) RH > 85% & Omega (-) over the northern Taiwan

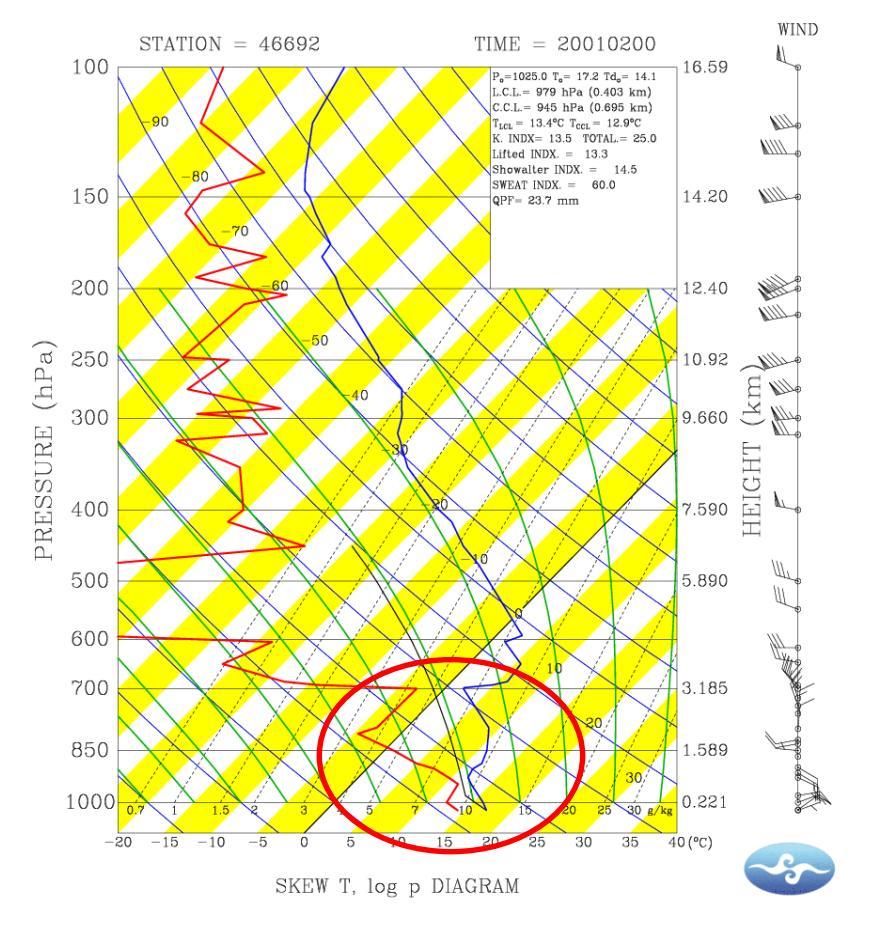
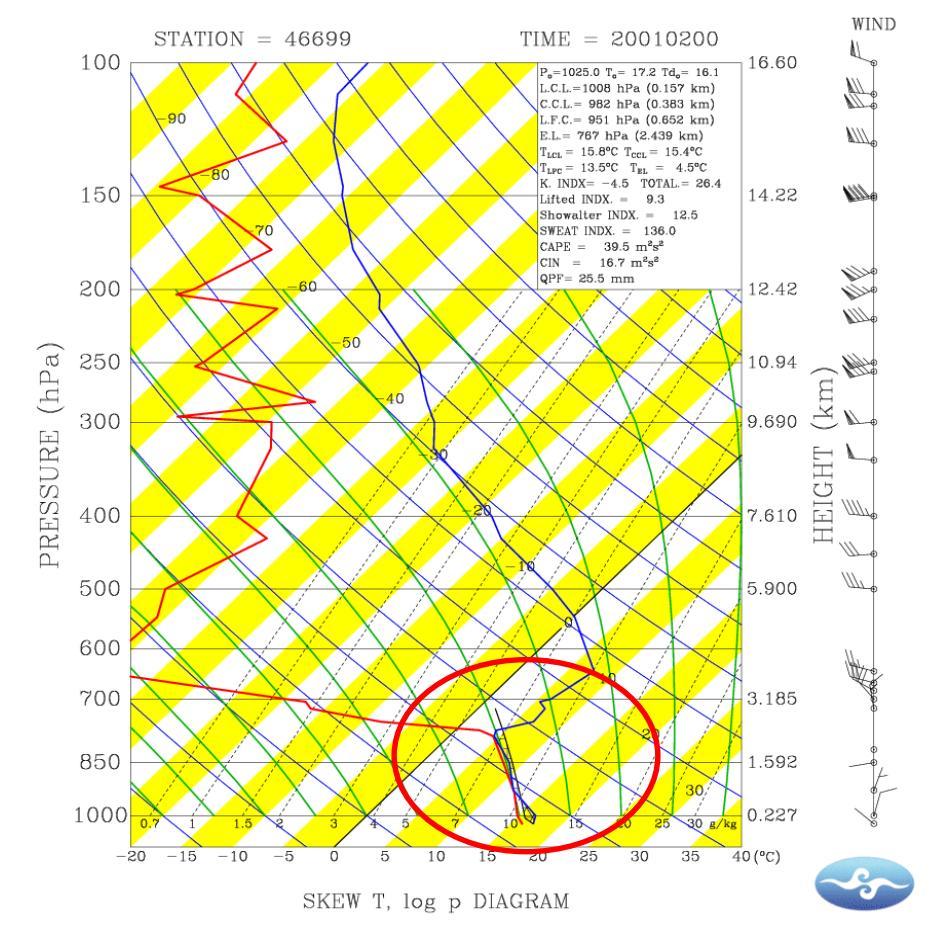
0800TST, Taipei Dry air and inversion

0800TST, Hualian Moist air and inversion

Fig. 3(a) The skew T, log p diagram of Taipei weather station at 0800TST (UTC+8) on 02 January 2020. (b) The same as (a) except at Hualian weather station. An evident inversion was identified at about the 780 hPa level. (Adopted from Central Weather Bureau)

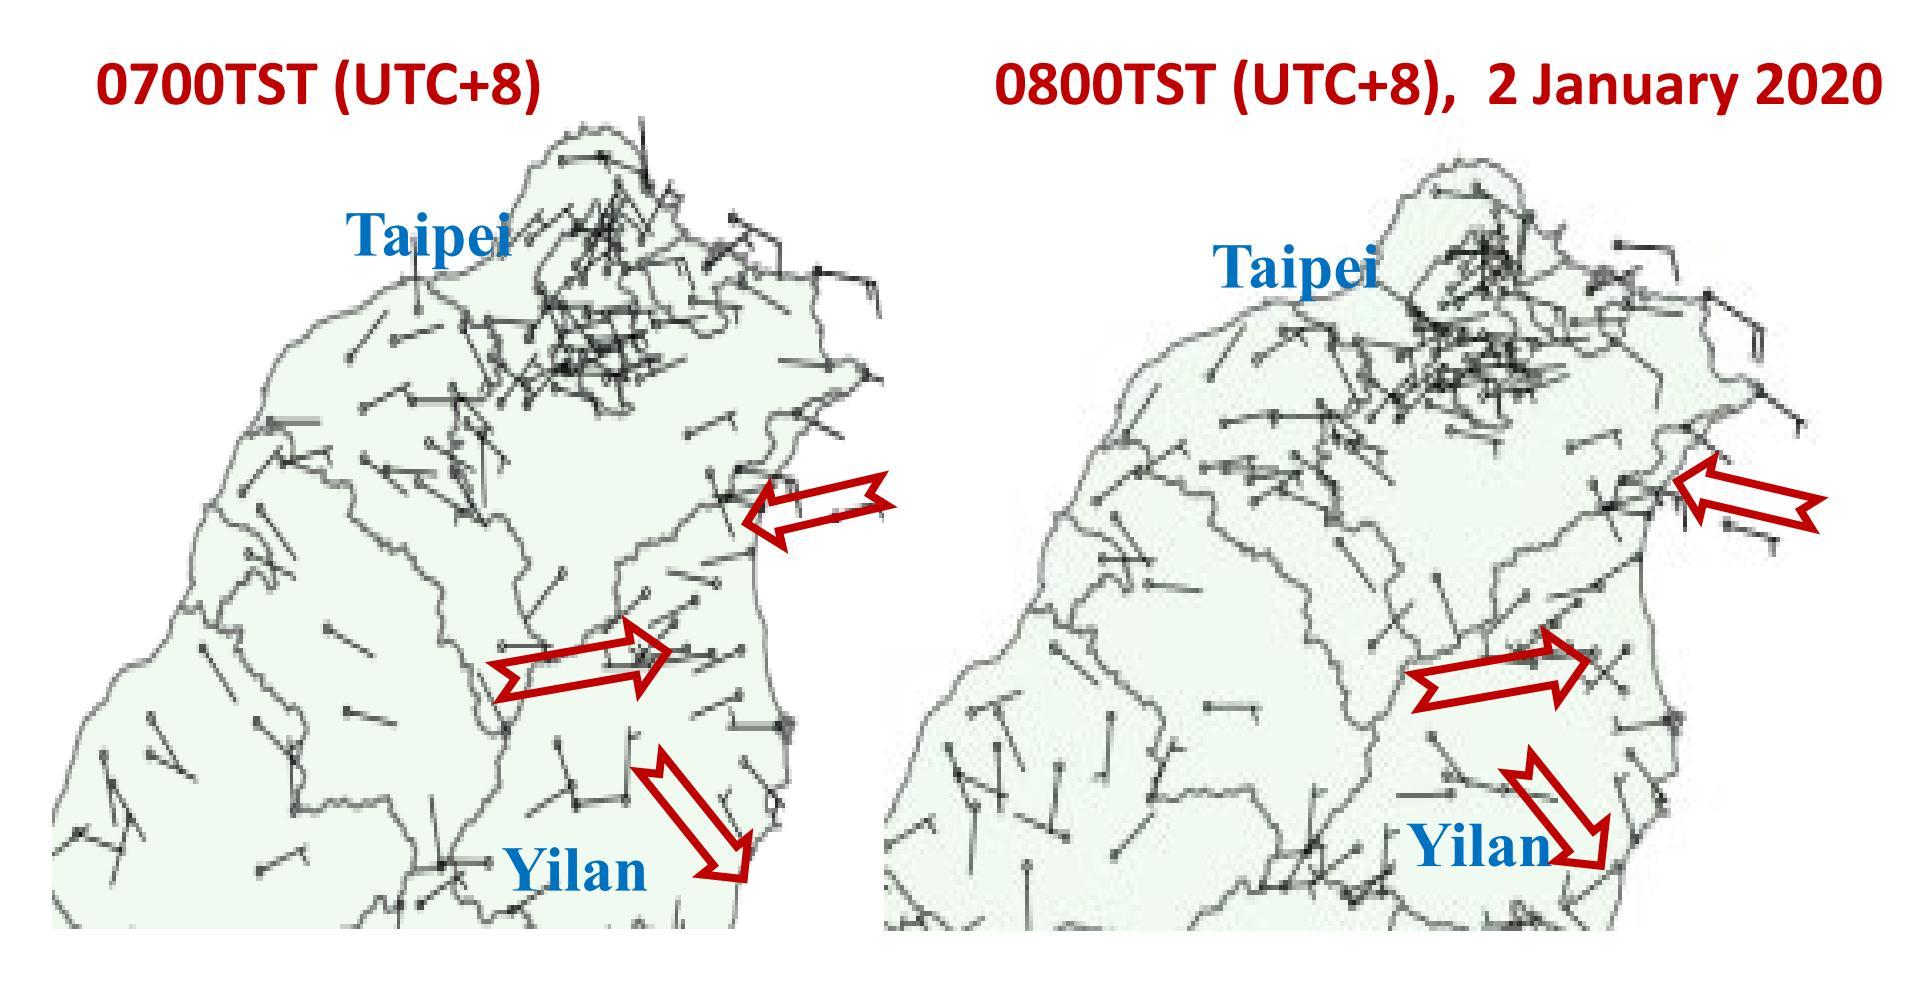
Fig. 5(a) The surface wind map at 0700TST (UTC+8) on 2 January 2020. An obvious convergence zone was formed over the Yilan Plain and the complex terrains. (b) The same as (a) except at 0800TST (UTC+8) on 2 January 2020. (Referred from the NCDR WATCH)

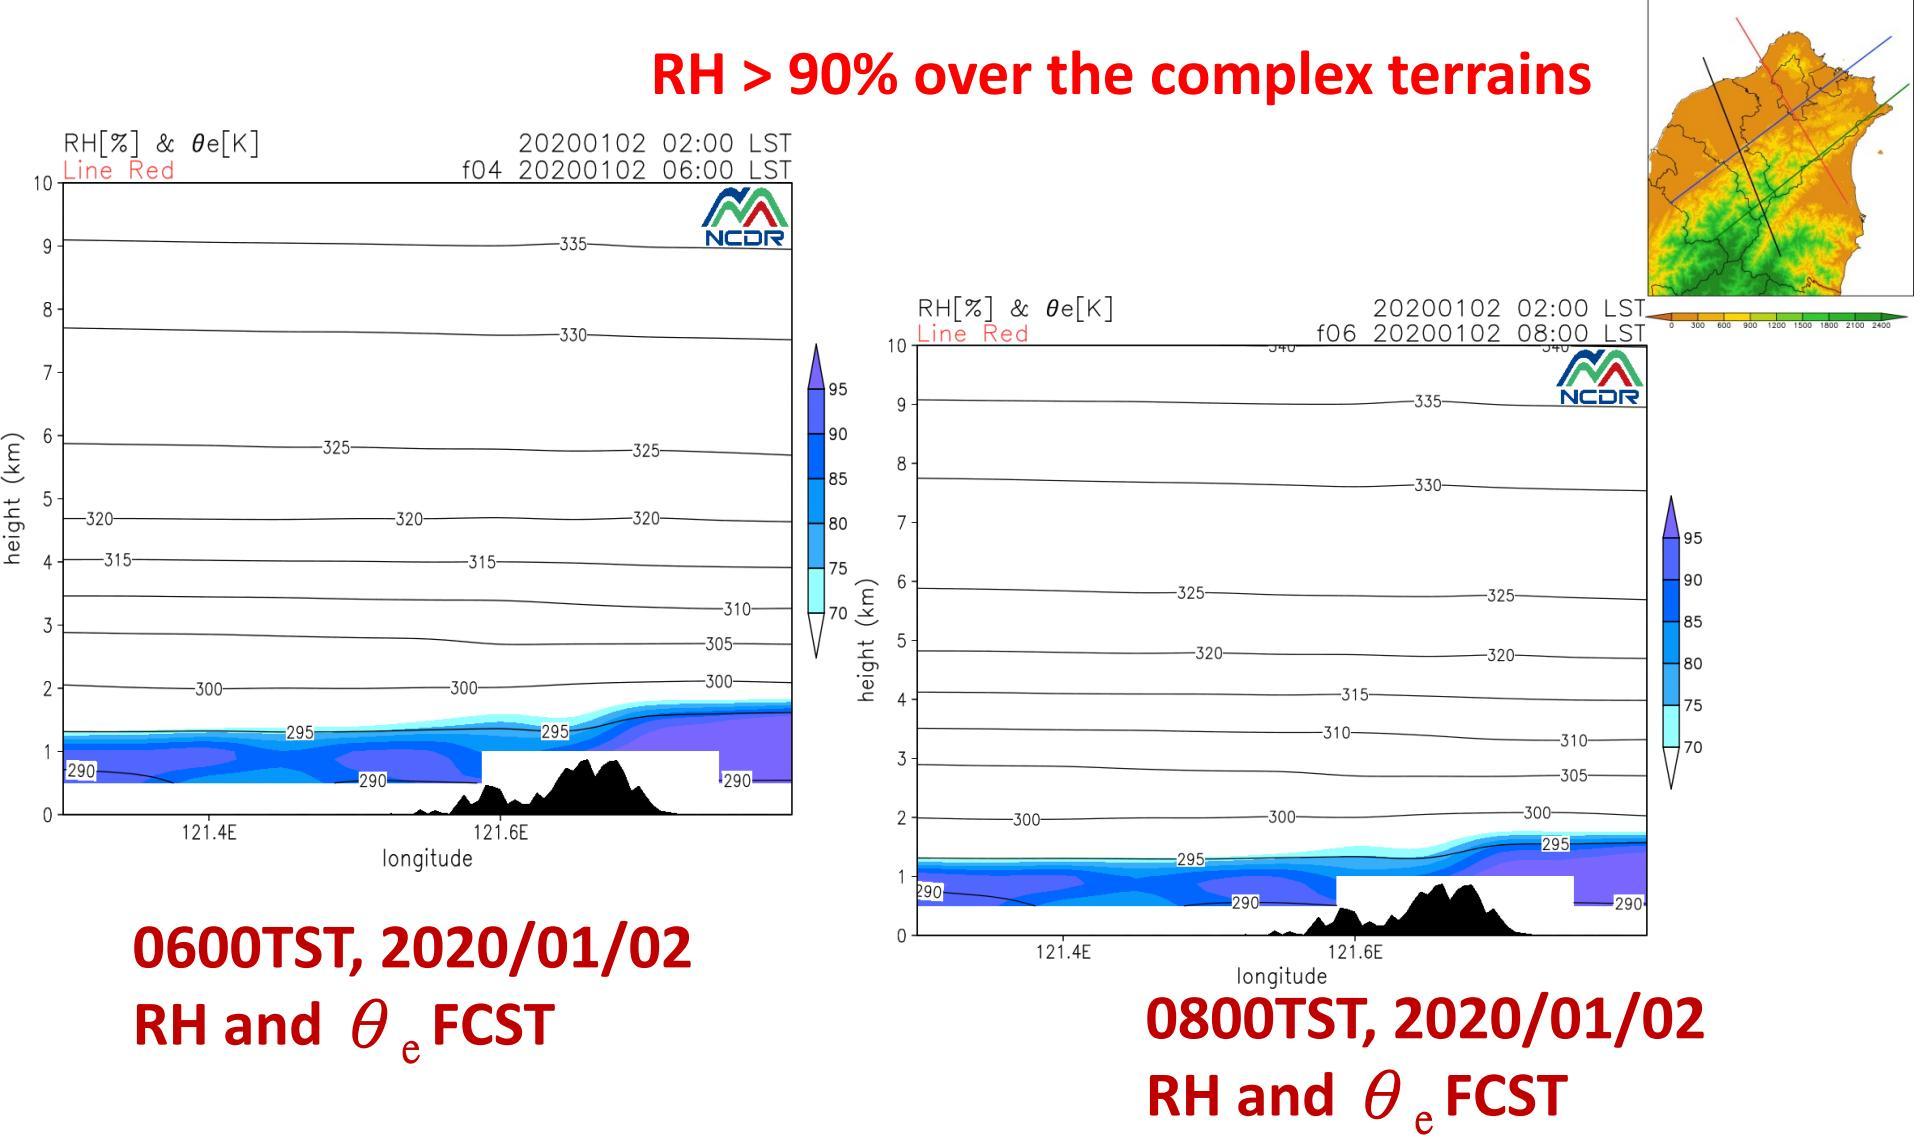
Fig. 6(a) Relative humidity(%) and equivalent potential temperature(°K) forecast valid at 0600 TST(UTC+8) of 2 January 20202 based on the observation of 0200 TST of 2 January 2020. (b) The same as (a) except at 0800 TST (UTC+8) of 2 January 2020. (Referred from NCDR WATCH)

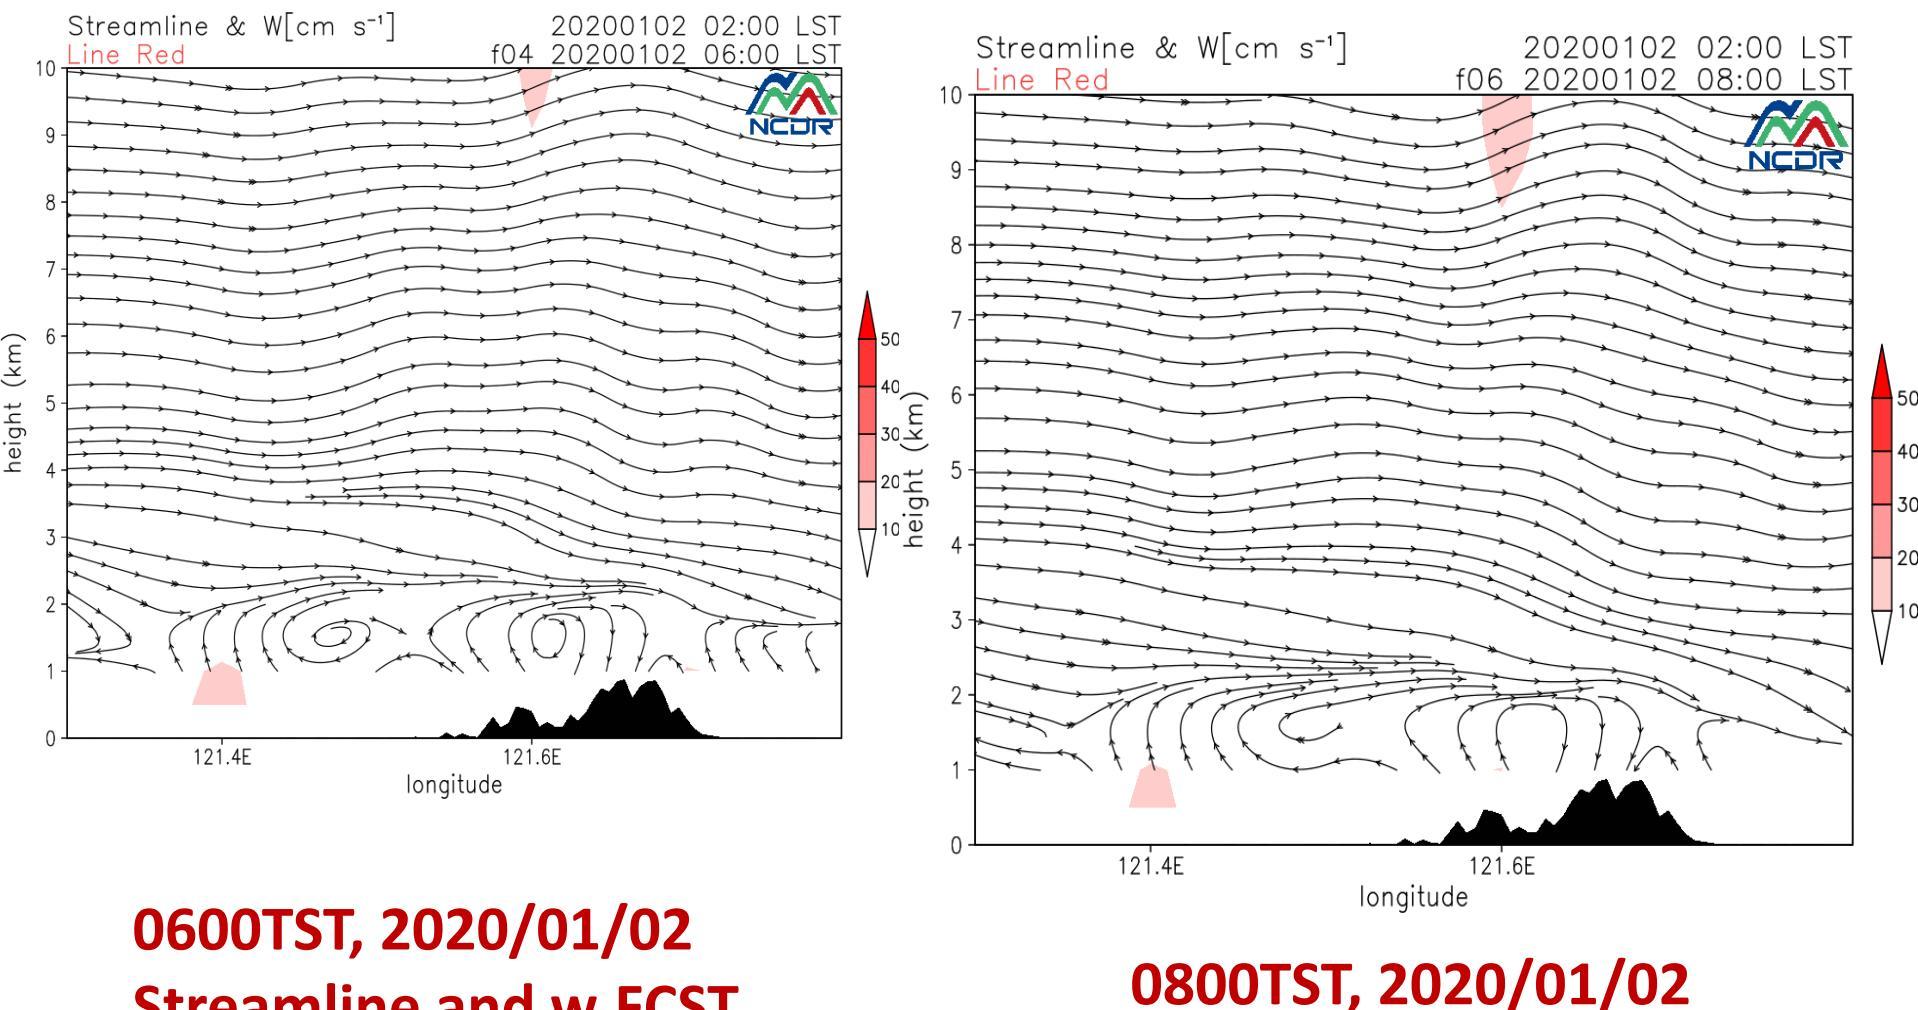
Fig. 7(a) Streamline and vertical velocity(cm/s) forecast valid at 0600 TST(UTC+8) of 2 January 20202 based on the observation of 0200 TST of 2 January 2020. (b) The same as (a) except at 0800 TST (UTC+8) of 2 January 2020. (Referred from NCDR WATCH)

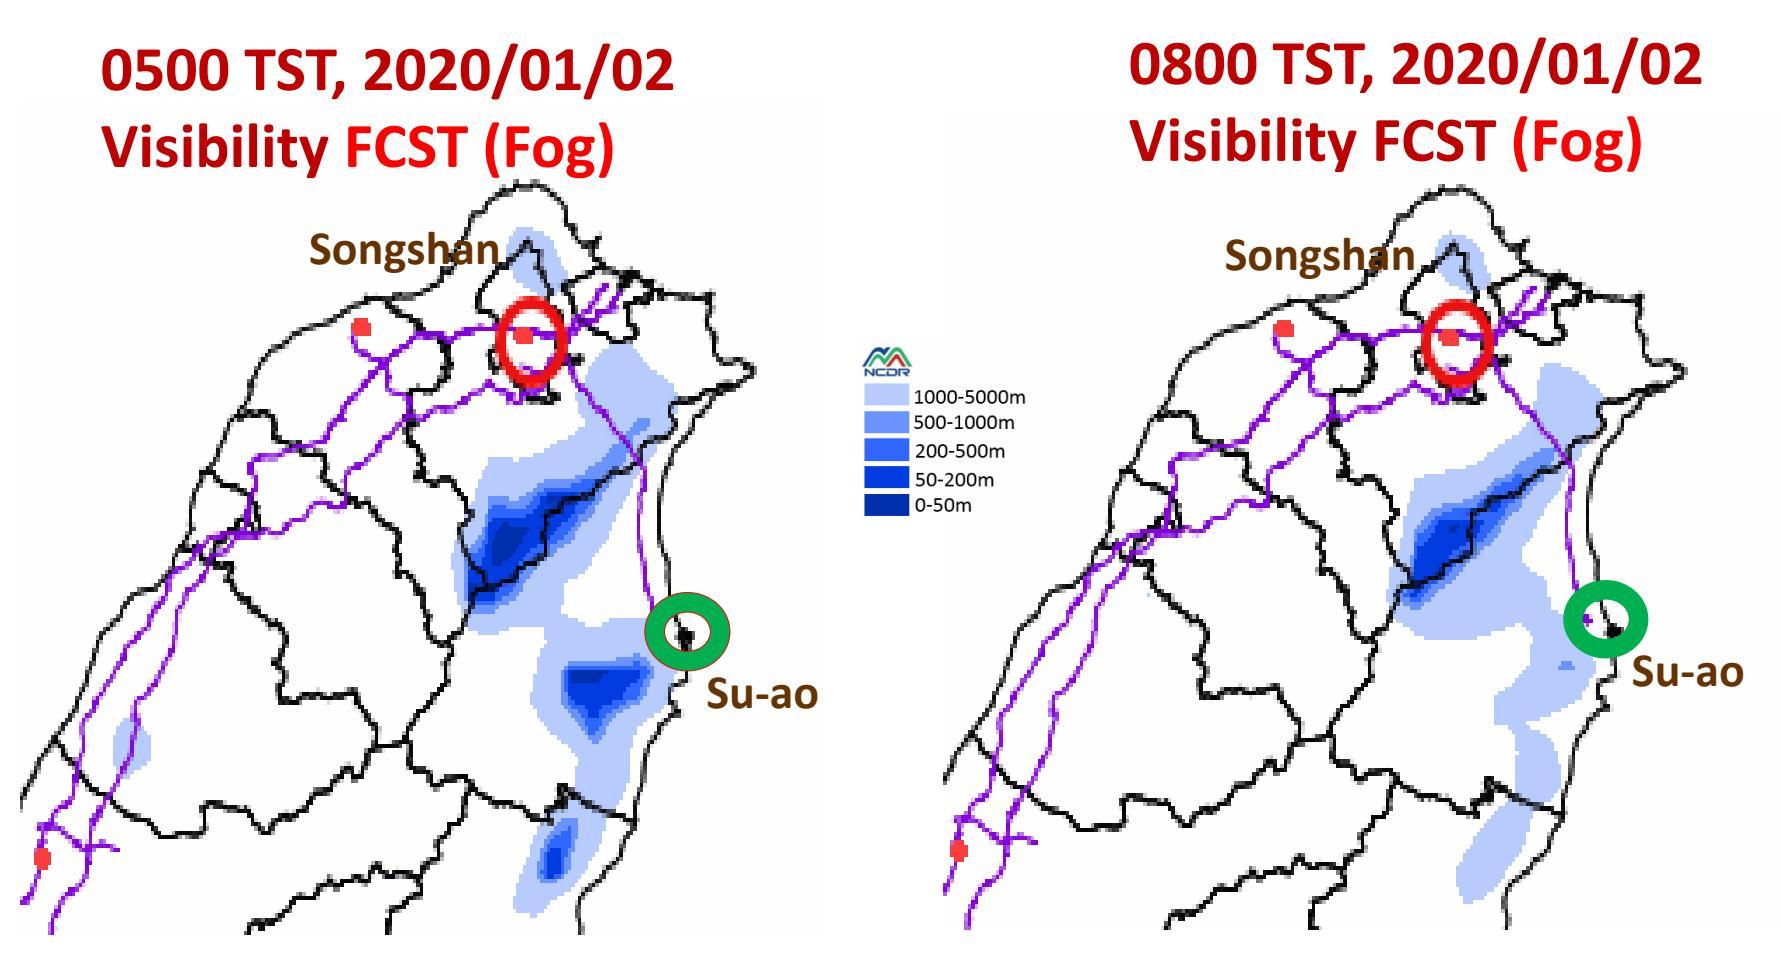
Fig. 9(a) Visibility forecast valid at 0500 TST (UTC+8) of 2 January 20202 based on the observation of 0200 TST of 2 January 2020. (b) The same as (a) except at 0800 TST (UTC+8) of 2 January 2020. The forecast offers the visibility difference initiated by the surface fog, excluding the effect of air pollution. The solid red and green circles represent the location of Taipei Songshan Airport and Su-ao Port, respectively, and the purple lines stand for the regular flight route C10. (Referred from NCDR WATCH)

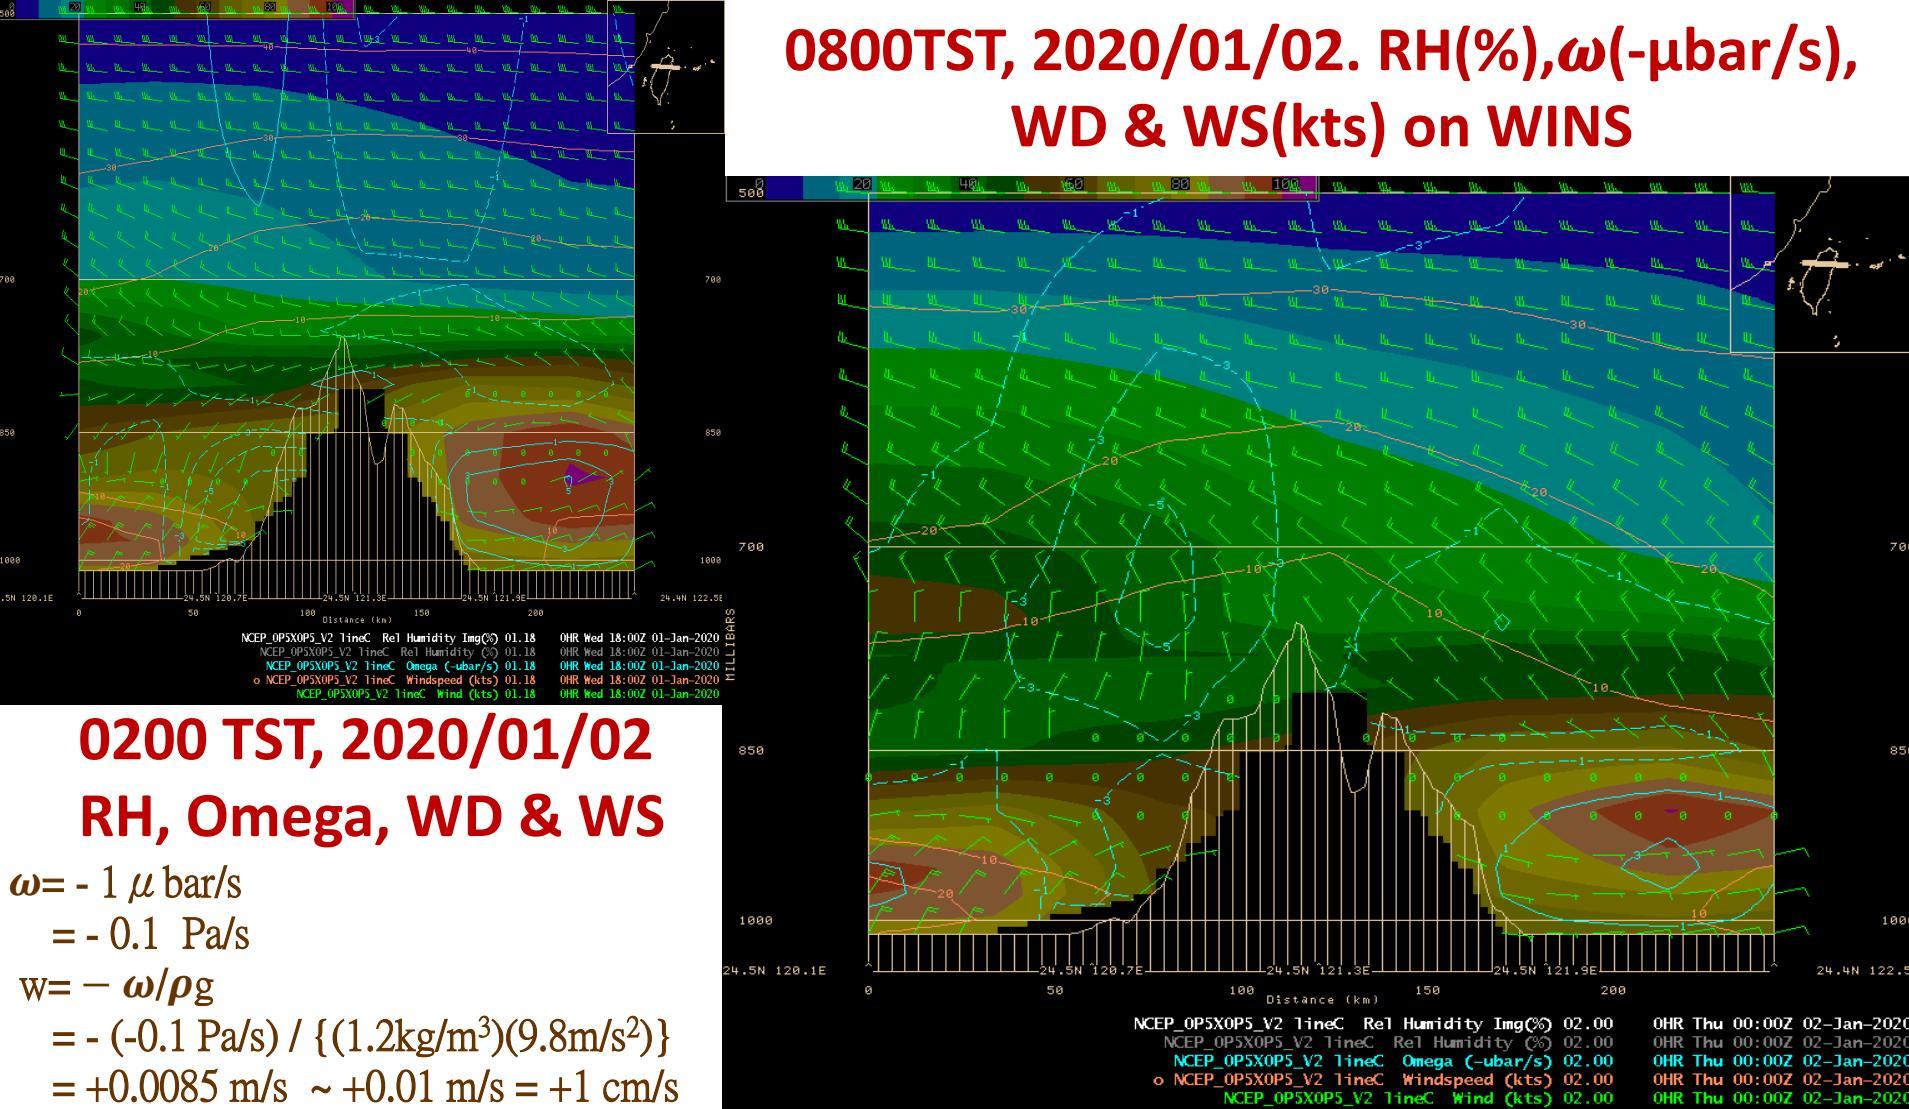
Fig. 8(a) The vertical cross section of relative humidity (%), omega (- µbar/s), wind direction and wind speed (kts) along 24.5°N between 120.1°E and 122.5°E based on the WINS (Weather Integration and Nowcasting System) data of Central Weather Bureau at 0200TST (UTC+8) on 2 January 2020. (b) The same as (a) except at 0800TST (UTC+8) on 2 January 2020. (Resulted from CWB/WINS) (尖石郷馬洋山2863m)

- The vertical cross section of relative humidity (%), omega (- µbar/s) and wind speed (kts) along 24.5°N between 120.1°E and 122.5°E based on the WINS data at 0200TST (UTC+8) and 0800TST (UTC+8) on 2 January 2020 delivered more reliable evidences, mentioning a locally vertical circulation with obvious upward motions in magnitude of 10⁻² m/s under the 850 hPa level over the plain area and slight downward motions over the complex terrains.
- Visibility forecast conducted by NCDR offered the visibility difference initiated by the surface fog, and illuminated the worst visibility was in the range of the 0-50 m over the complex terrains.

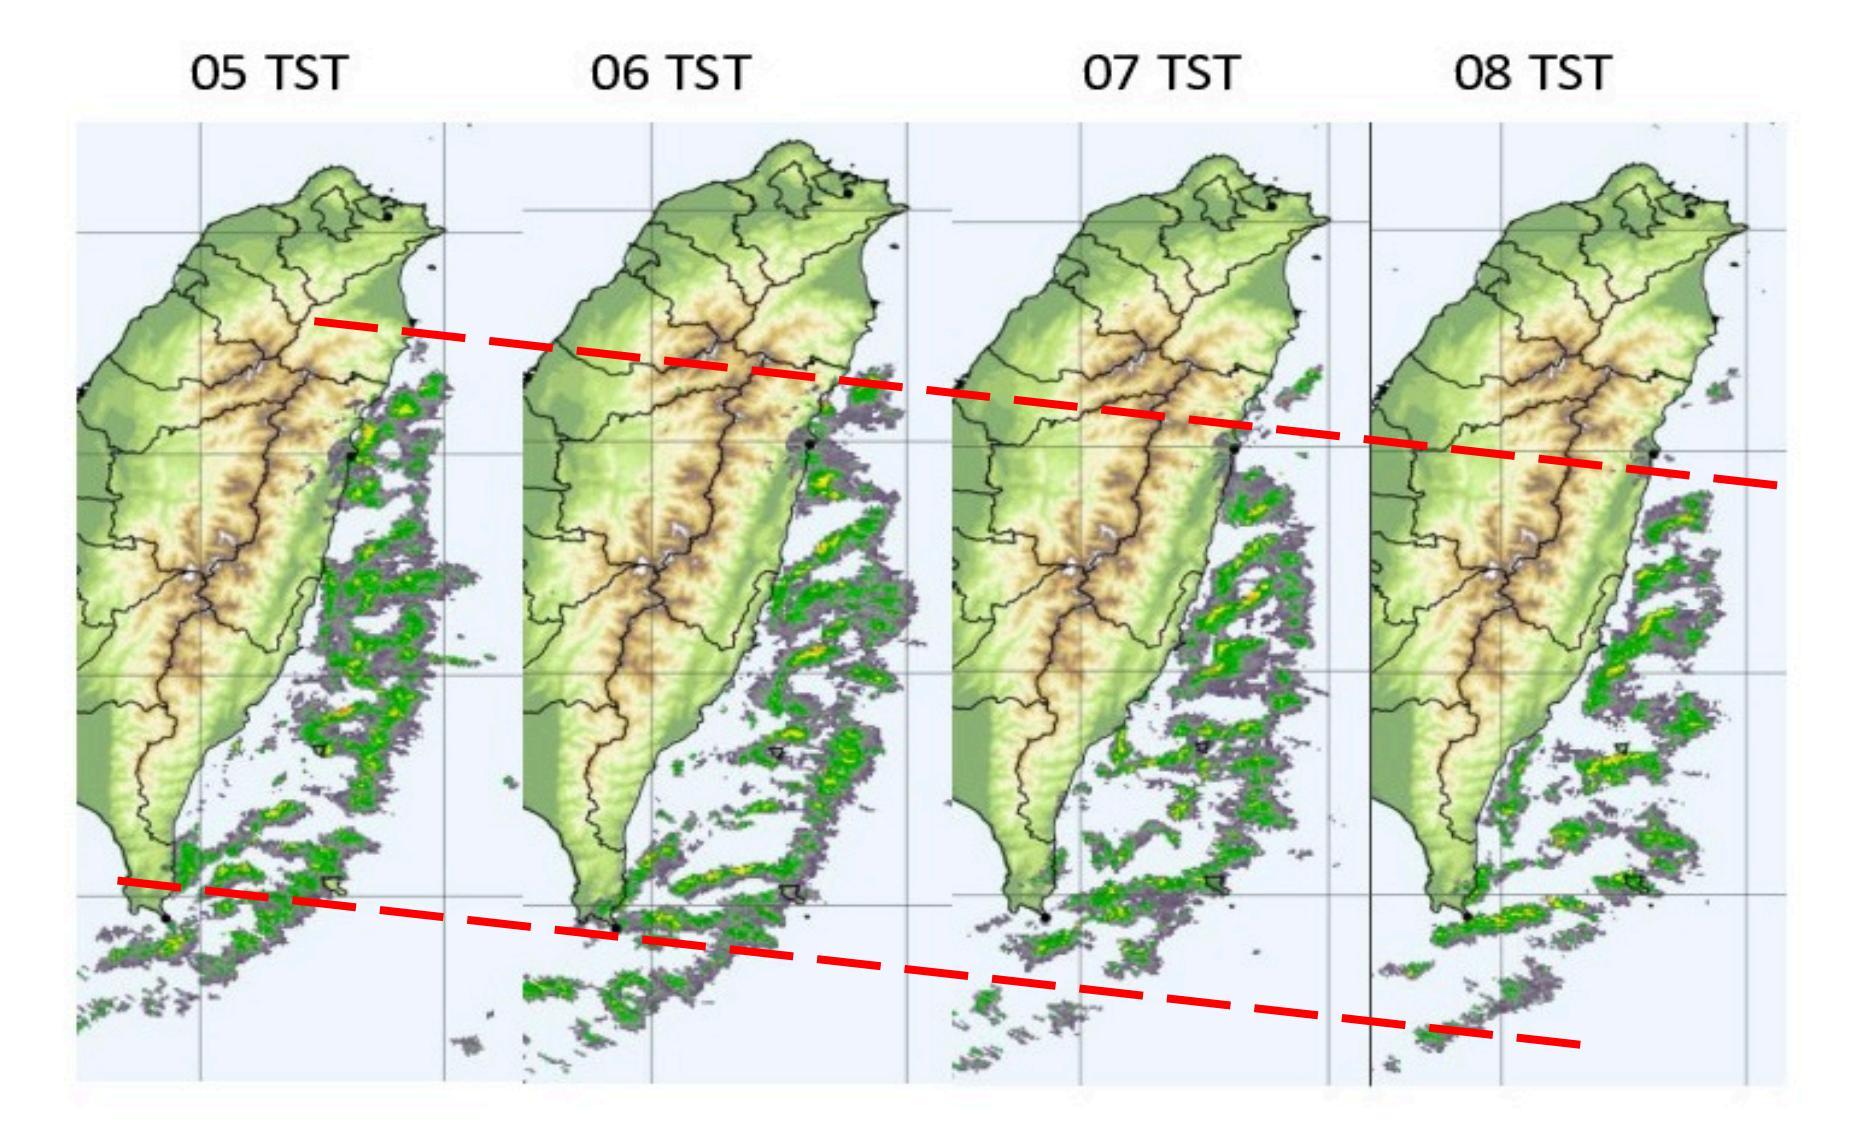
Fig. 11 (a) Composite radar reflectivity at 0500TST on 2 January 2020. (b) The same as (a) except at 0600TST on 2 January 2020. (c) The same as (a) except at 0700TST on 2 January 2020. (d) The same as (a) except at 0800TST on 2 January 2020. (Referred from the Central Weather Bureau)

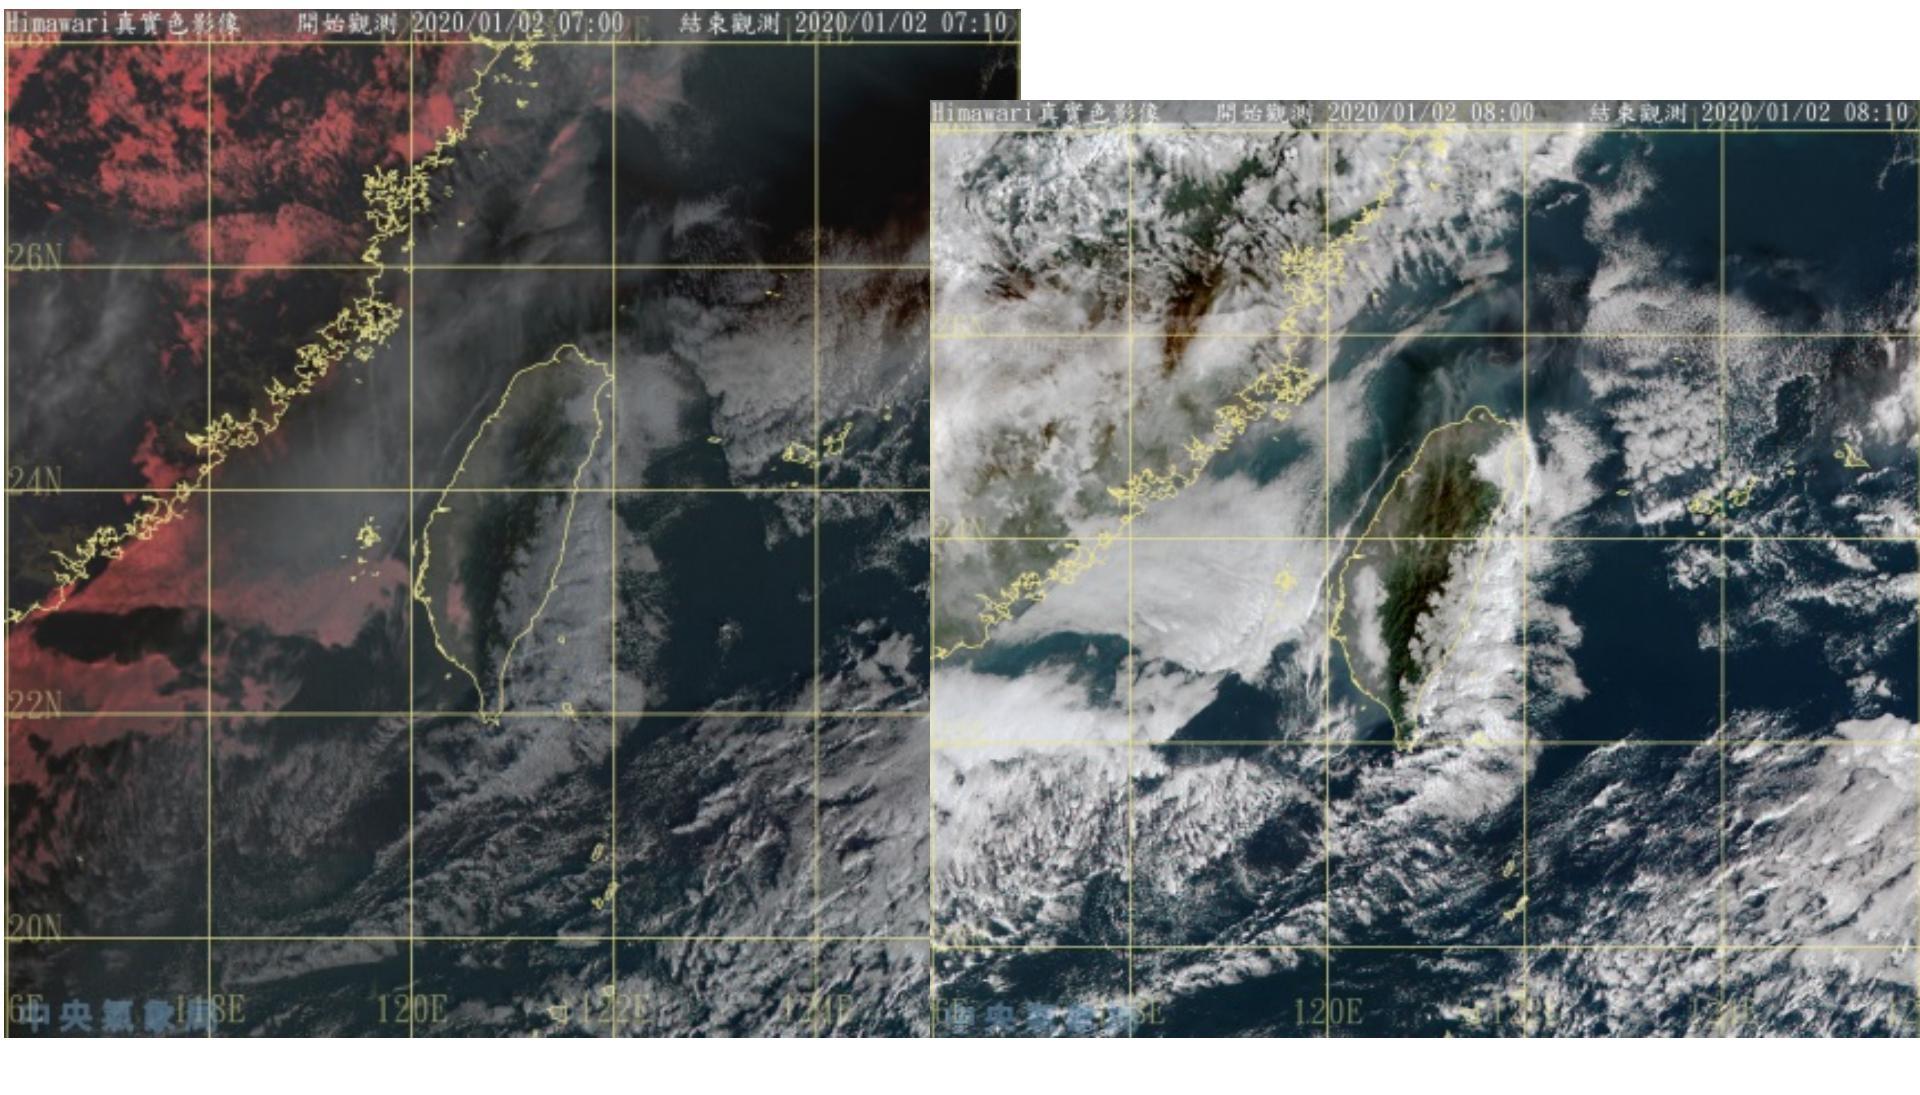
Fig. 12 (a) Himawari8 true color satellite image at 0700TST (UTC+8) on 2 January 2020. (b) The same as (a) except at 0800TST on 2 January 2020. (Referred from the Central Weather Bureau)
